JAMES GILLESPIE'S HIGH SCHOOL CONSERVATION PLAN

DRAFT REPORT

03 December 2010

Prepared for The City of Edinburgh Council

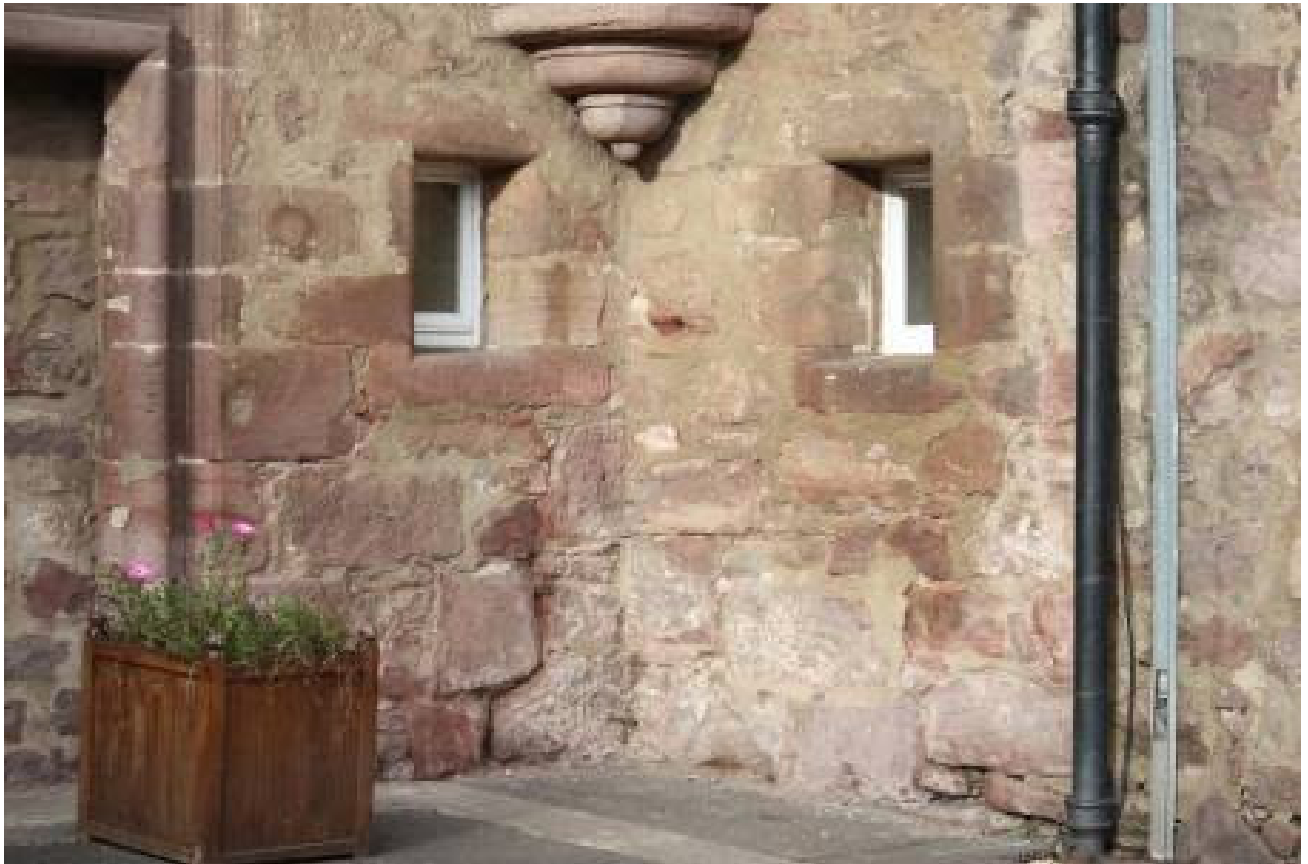
The exterior of the house has some signs of damp at its base. The stone work is crumbling away and this is especially evident on the south façade. This requires to be investigated further as it's likely the building does not have a sufficient damp proof course. On the east elevation facing into the entrance courtyard there is evidence of a mortar seal to the base of the building.

Evidence of damp and stone decay to base of Bruntsfield House – South elevation

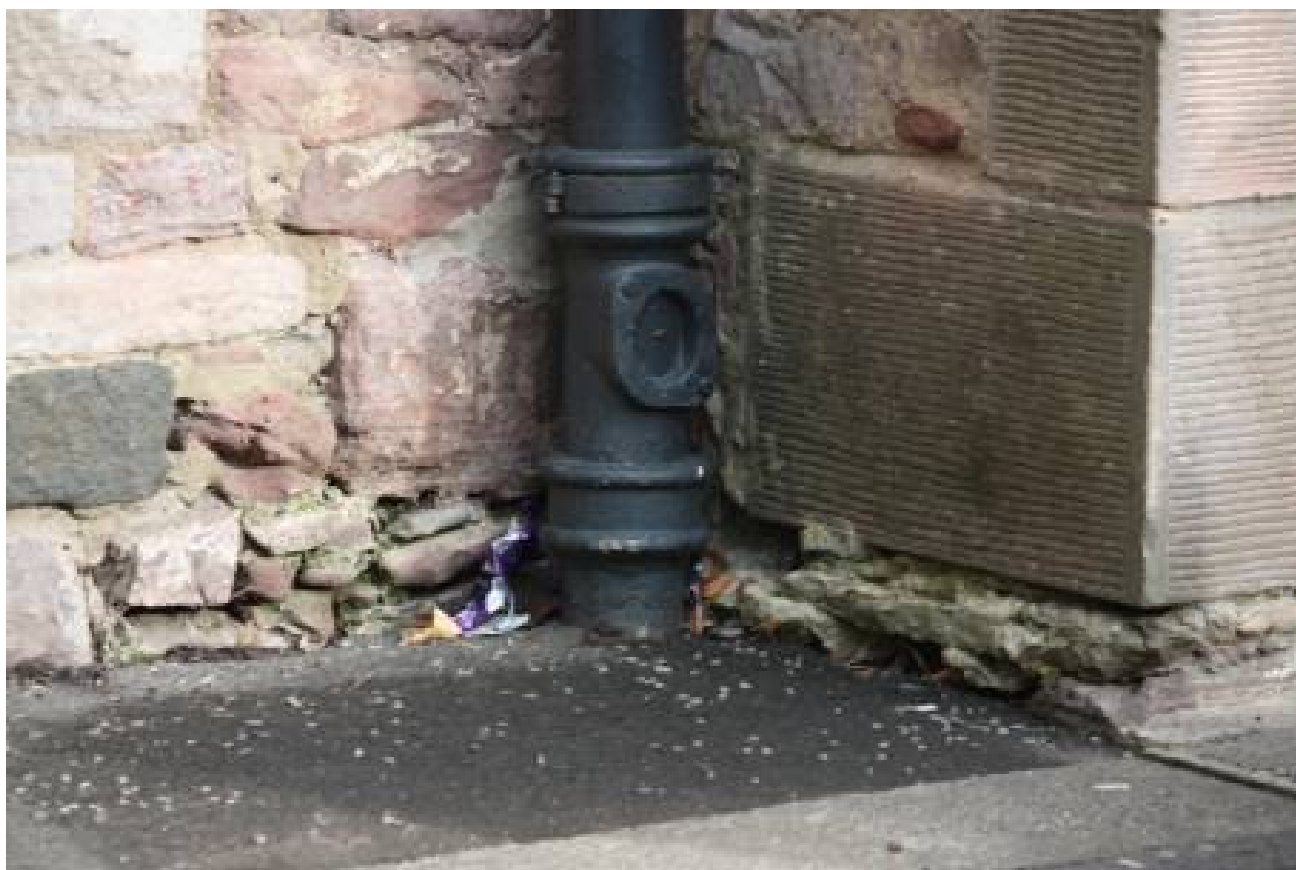
Evidence of damp and stone decay to base of Bruntsfield House – South elevation

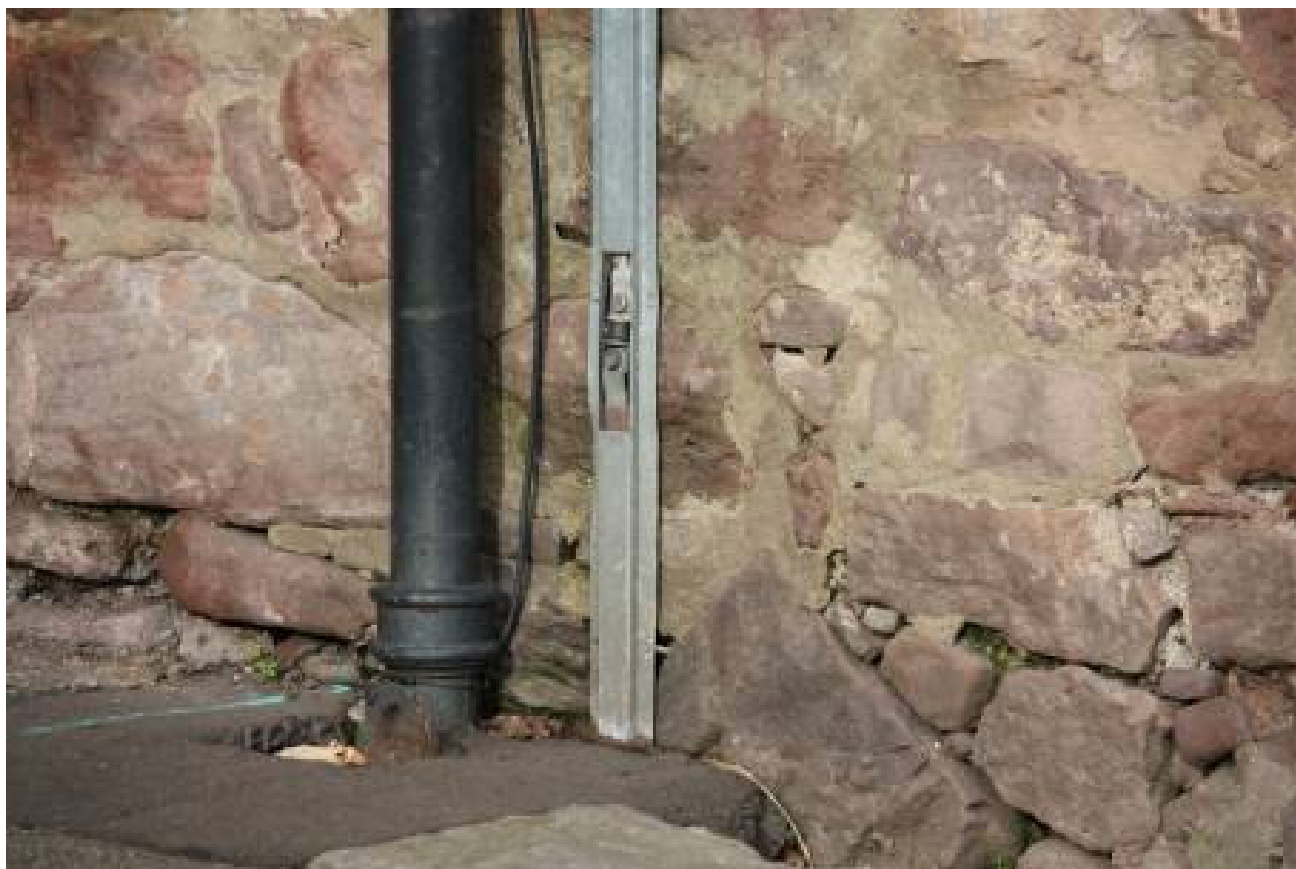
Deteriorating Stonework

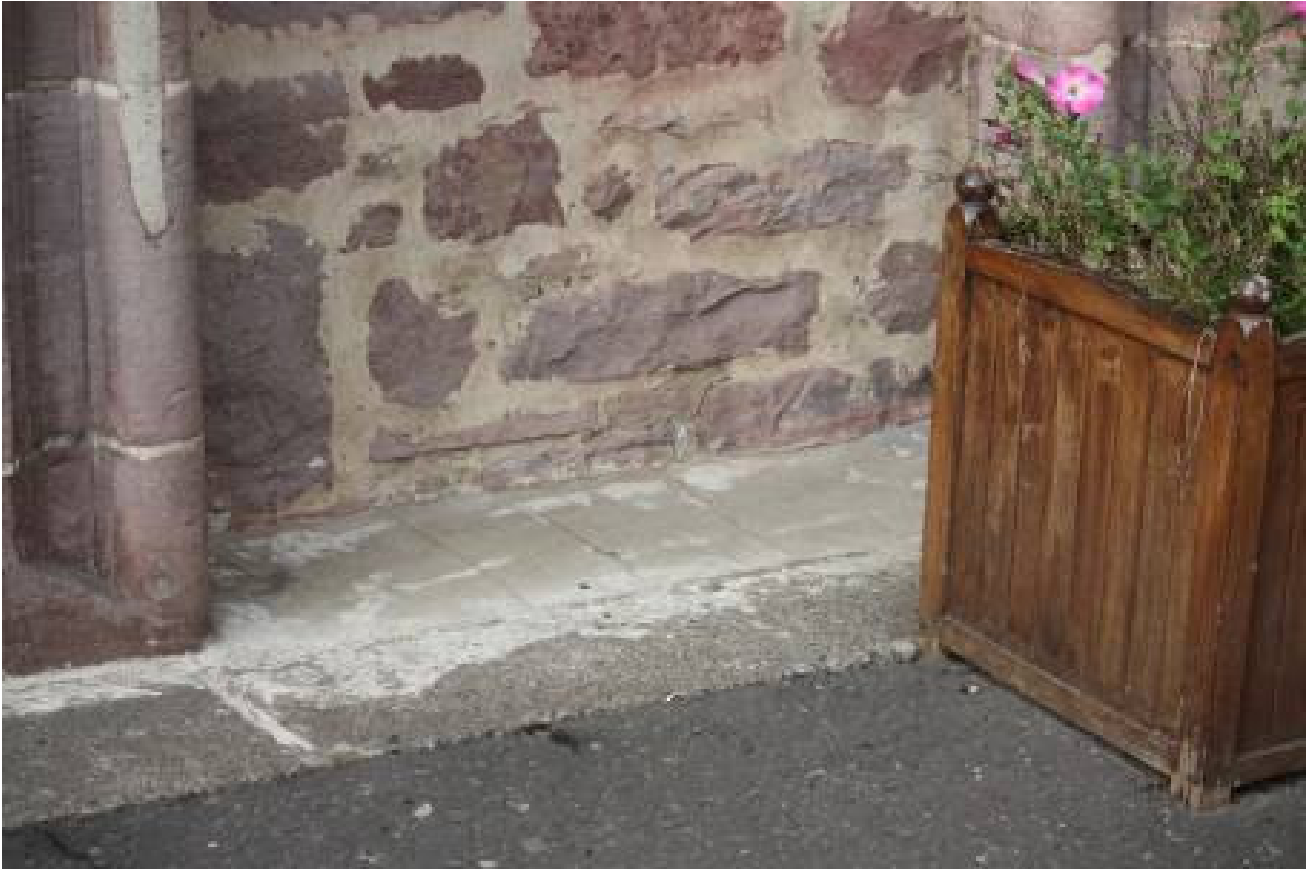
Mortar Seal on east elevation

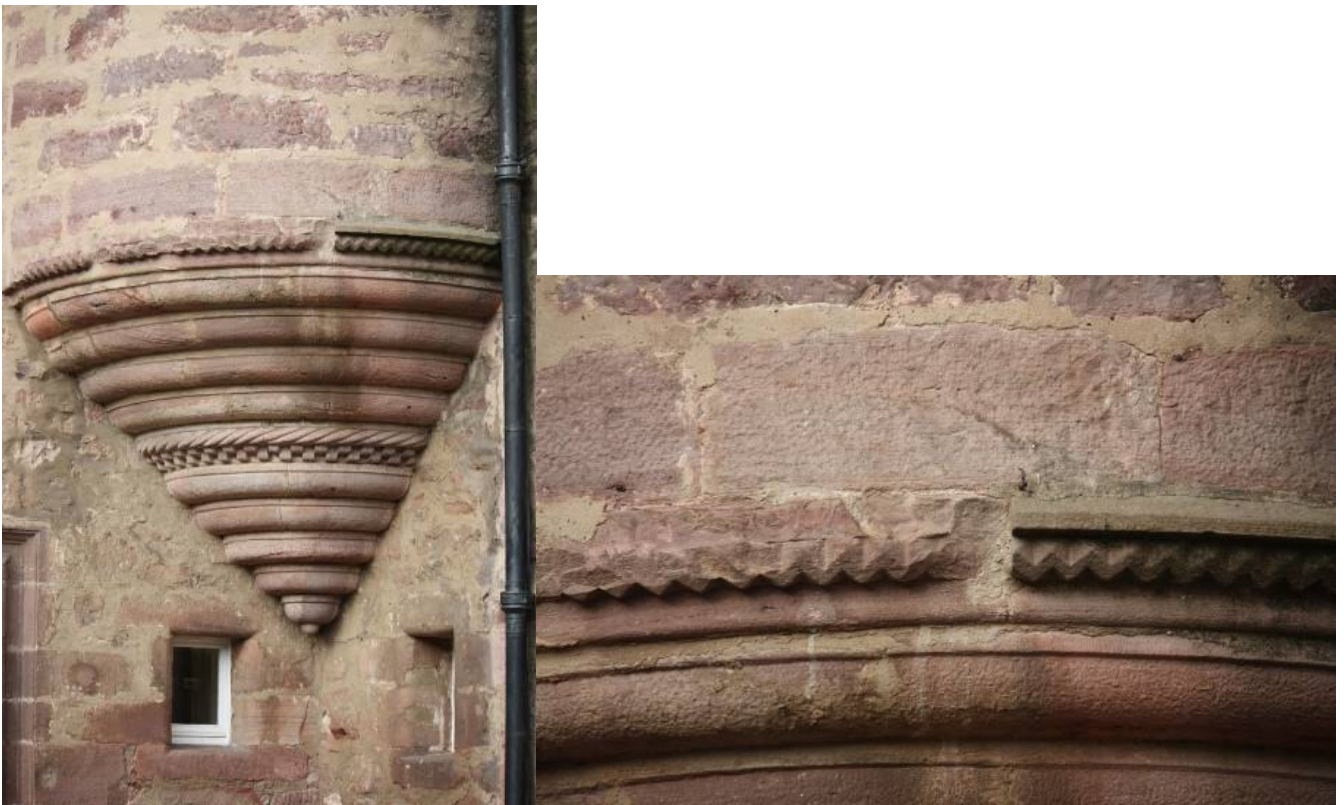
The base of the turret on the south façade has areas of zig zag stone molding missing. This should be replaced and the condition of remaining areas investigated to prevent further sections falling off.

Missing carved stonework to base of stair tower turret

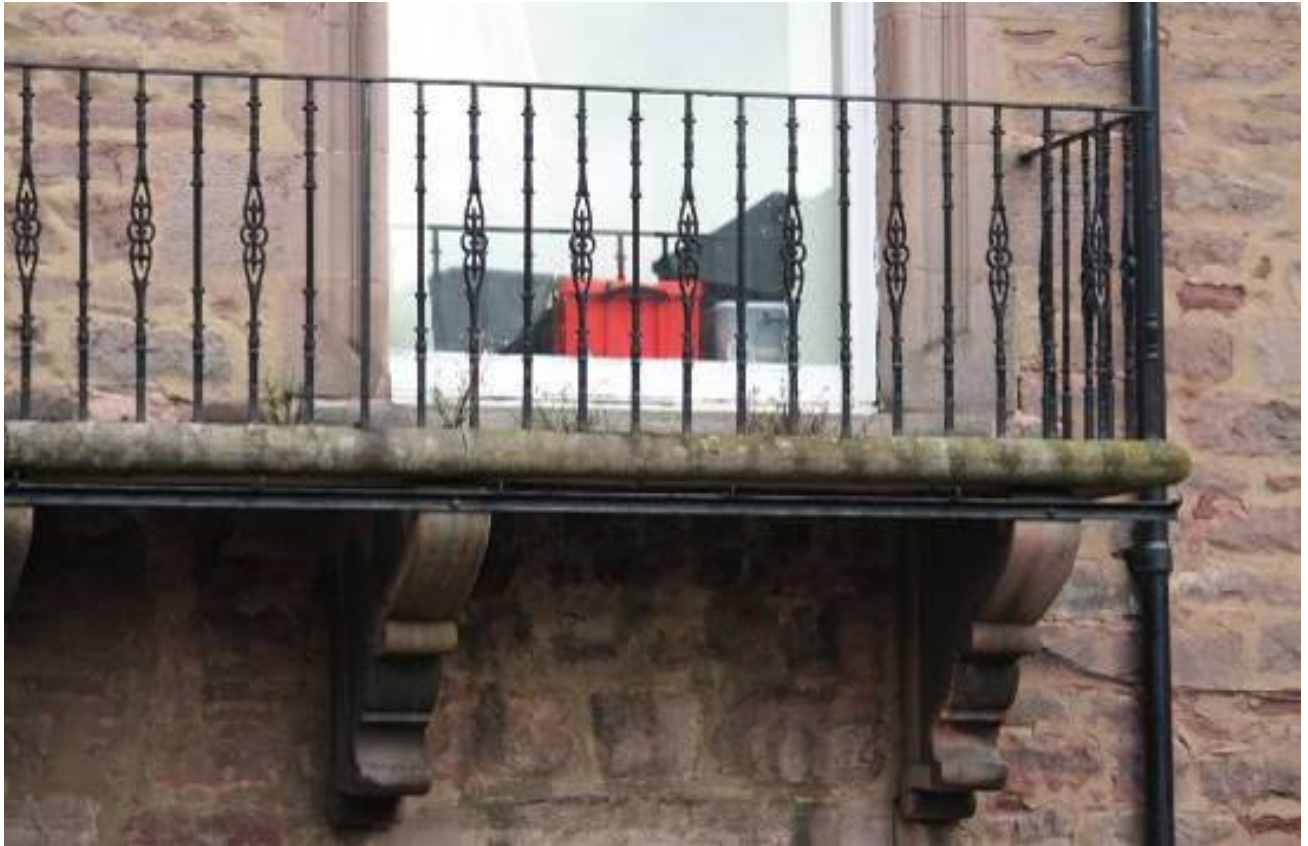
There is environmental staining to the stone scroll supports to the 19th century balcony. This should be monitored although there is no reason at present to clean the stone. Plant growth should be removed from the balcony and the condition of the wrought iron balustrade reviewed. The paint finish to them is well maintained at present.

Environmental staining to balcony and evidence of plant growth

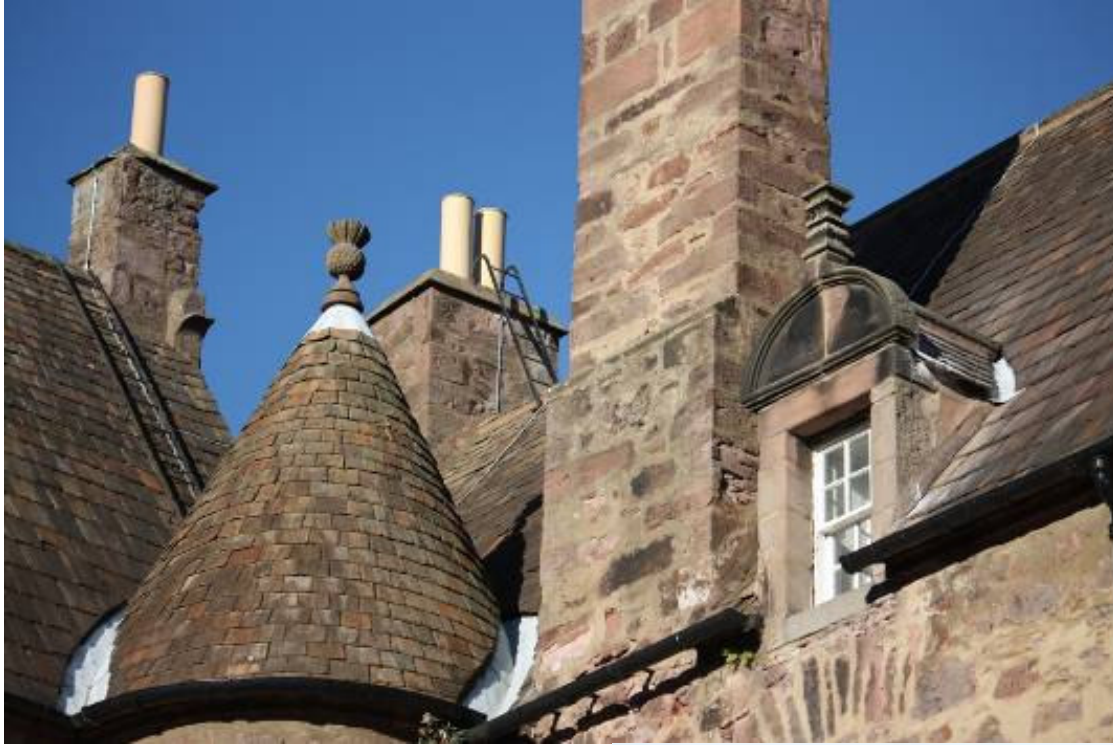
Elsewhere on the south façade there is evidence of missing mortar and stone deterioration. This mainly occurs at the base of the chimney breast to the west of this elevation and is likely to be caused by plant growth in the gutter in this location that is also badly fixed. The down pipes in the corners of the original building on this elevation are also showing signs of leakage that is affecting the surrounding stone work. This needs to be rectified before further damage to the shell of the building occurs.

Decay to stonework at base of chimney

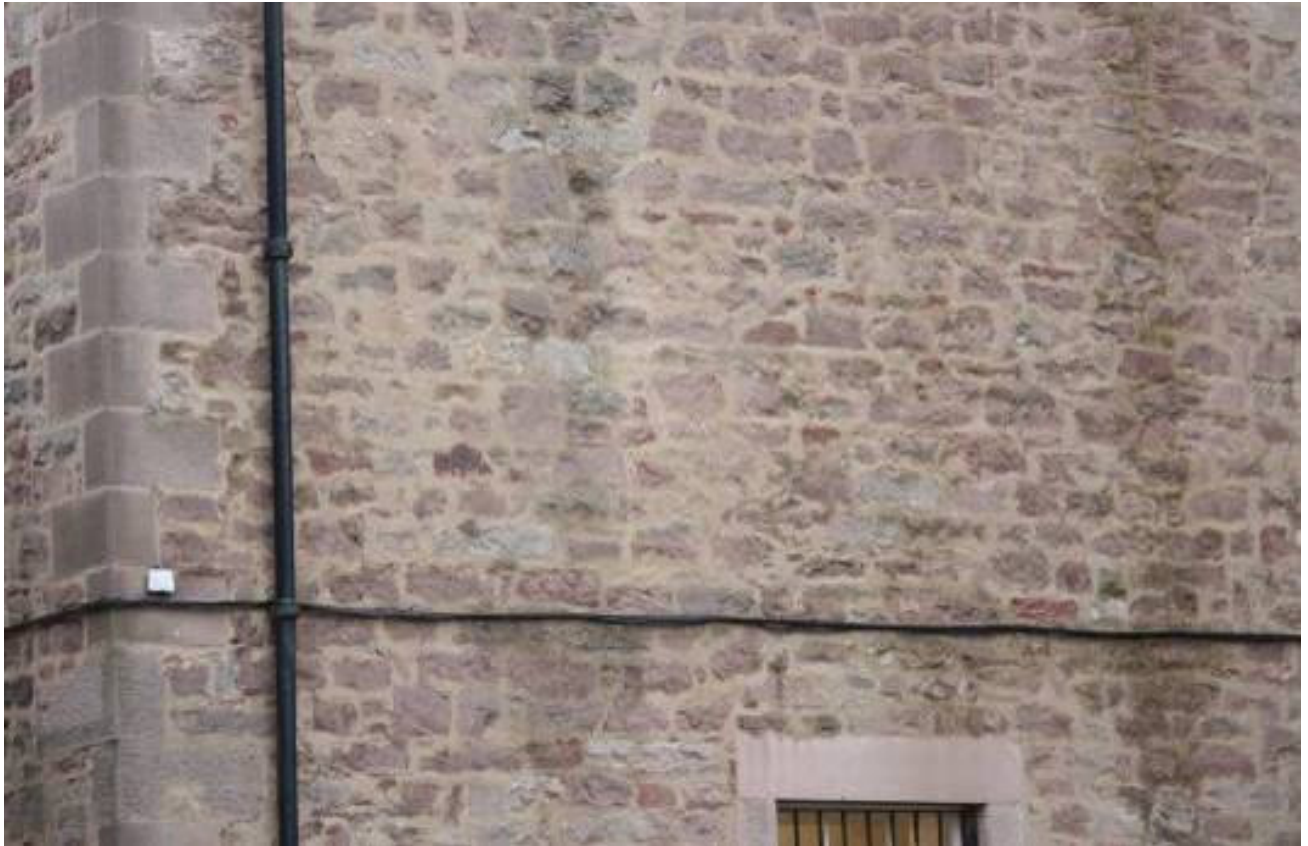
To the north elevations there is also evidence of cracking and deterioration to the stonework but it is generally in fairly good condition To the east end of the north elevation there is considerable bands of staining to the stonework which is caused by faults in the rainwater goods. This needs to be repaired to prevent any further decay to the stonework.

Staining to north elevation due to damaged rainwater goods

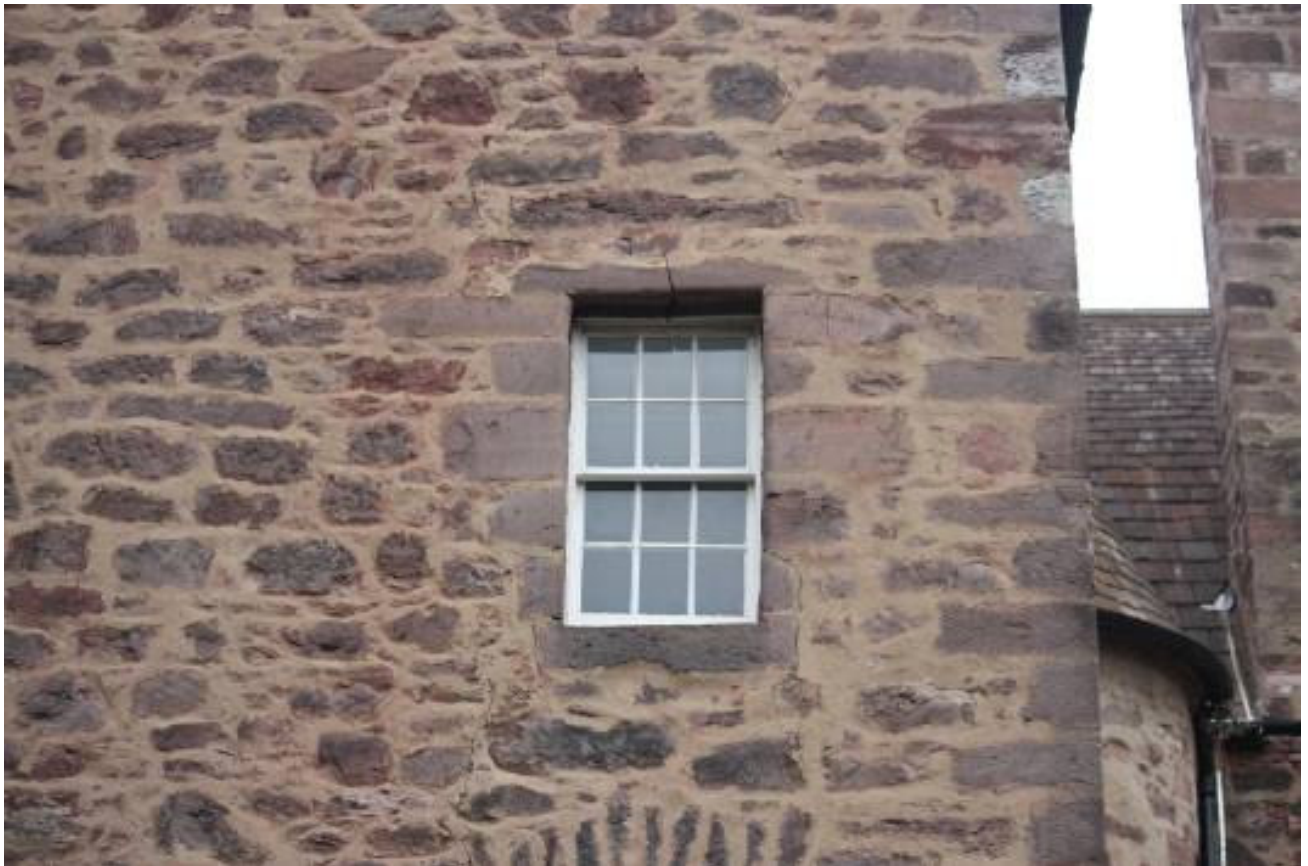
The lintol to the top floor window on the far west side of the south elevation has a large crack in it that is causing obvious subsidence internally. The cause of this and proposals for repair should be investigated.

Crack to lintol above top floor window, south elevation

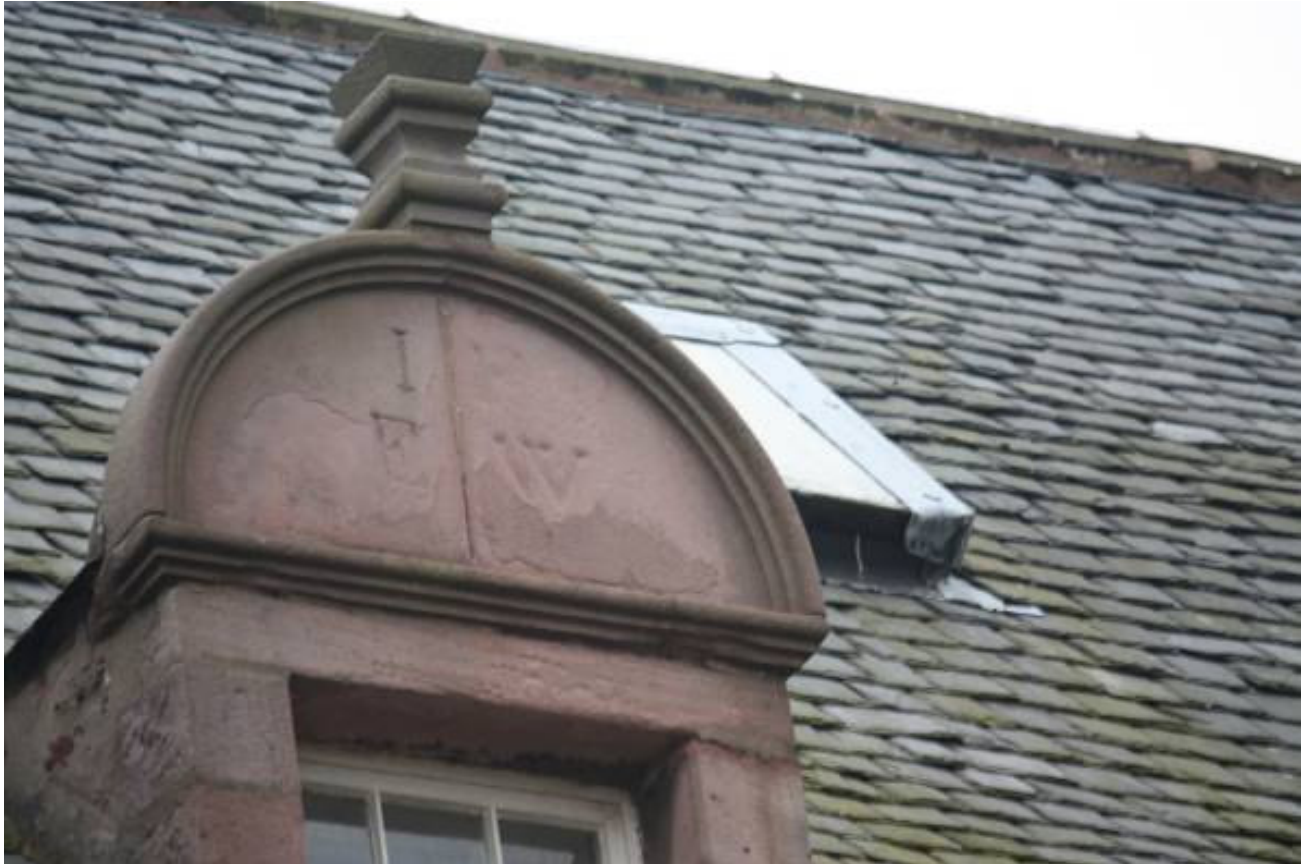
There is evidence of delamination to the carved dormer window heads sandstone on the top floor of the south façade, but in general this stonework is in fairly good condition given its age. There are areas of stone decay on the façade and they tend to occur around the windows.

Delamination and wear to carving above window

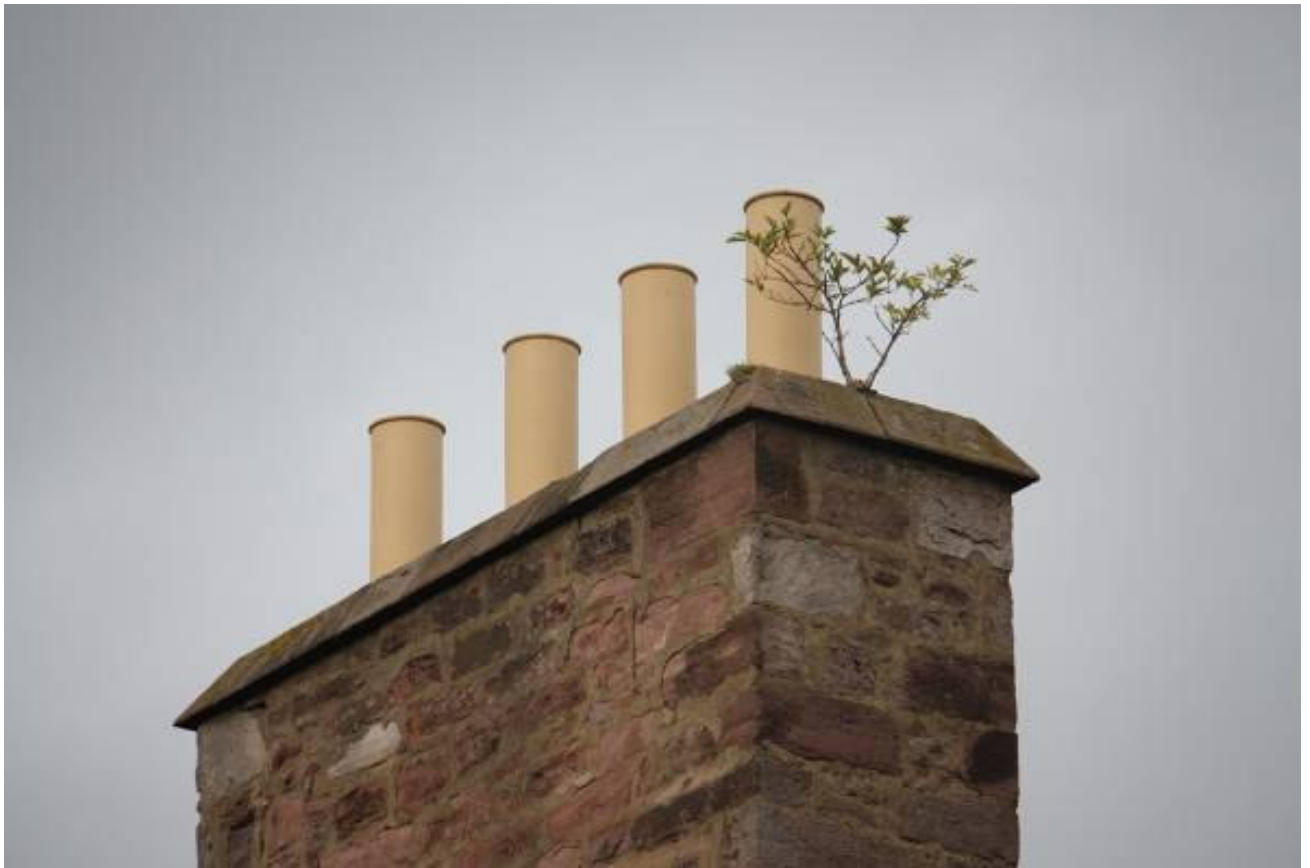
Plant growth to chimney

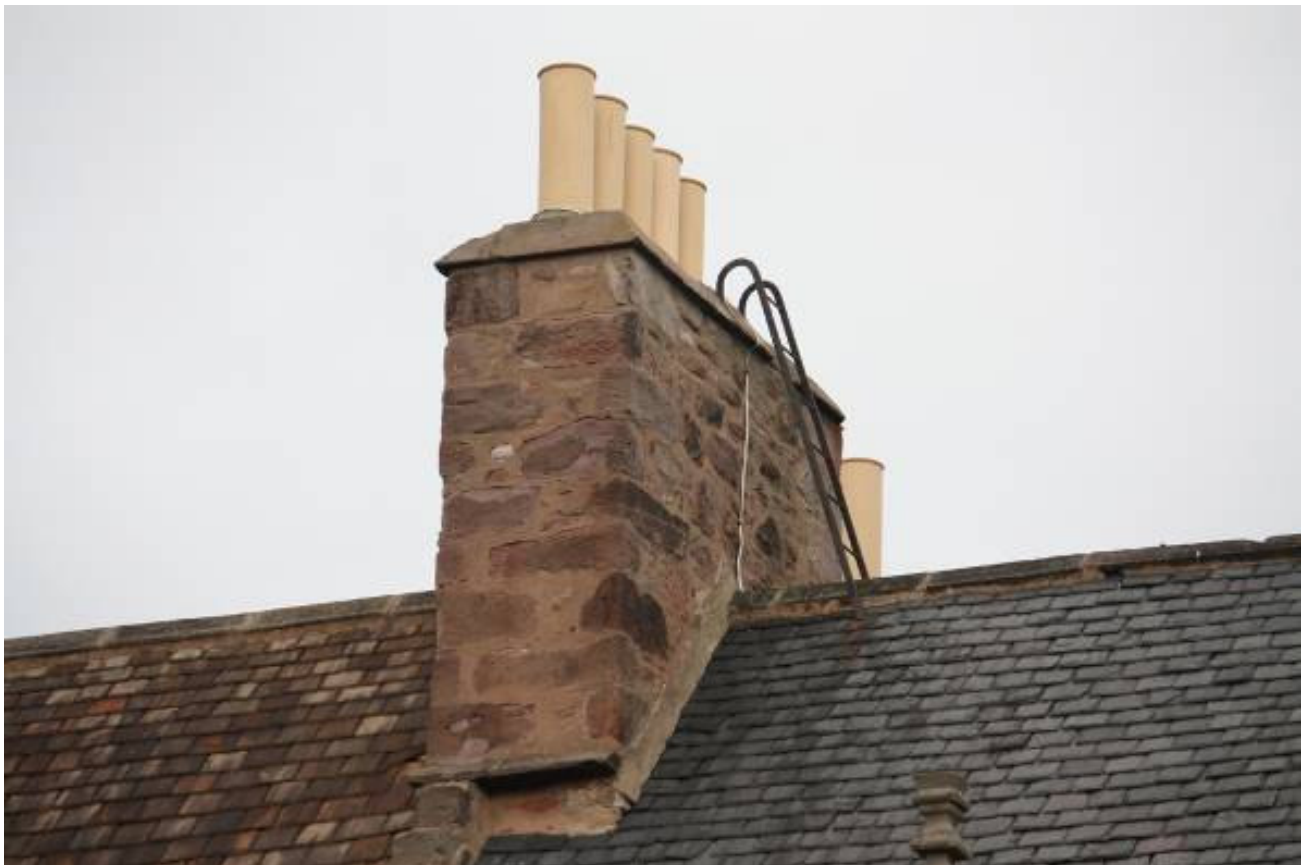
In general the slate roof to the east wing of the building is in good condition with little evidence of slates missing or slipping. The ridge is showing signs of decay in its centre and this should be repaired to prevent further water ingress into the attic rooms. Review of these rooms internally does suggest some evidence of mild water ingress and this is also prevalent around the skylights to the north side. The lead flashings around the dormers and the rooflights should be checked to ensure they are giving the correct level of protection. The same situations also occur on the tiled roof of the older section of the house. The chimneys in this area also show evidence of plant growth that needs to be removed. The high chimney to the south is unsupported and at present is not showing signs of deterioration but consideration should be given to its safety and the possible introduction of some supports to the rear. On the north side of the roof there is evidence of metalwork decay to the gutters. These should all be cleared on a regular basis to prevent blockage occurring.

Deterioration to stonework on chimney and ridge of slate roof

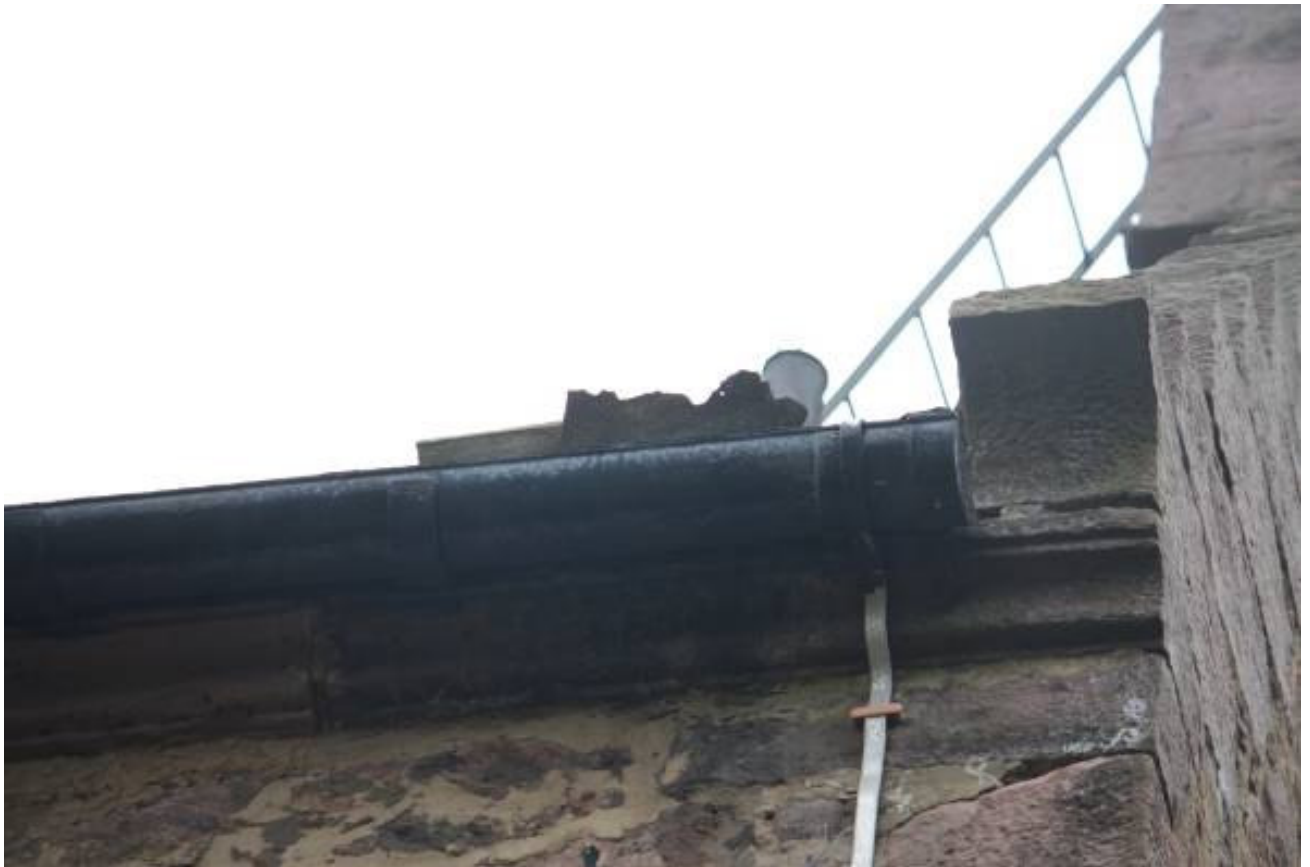
Gutters Blocked

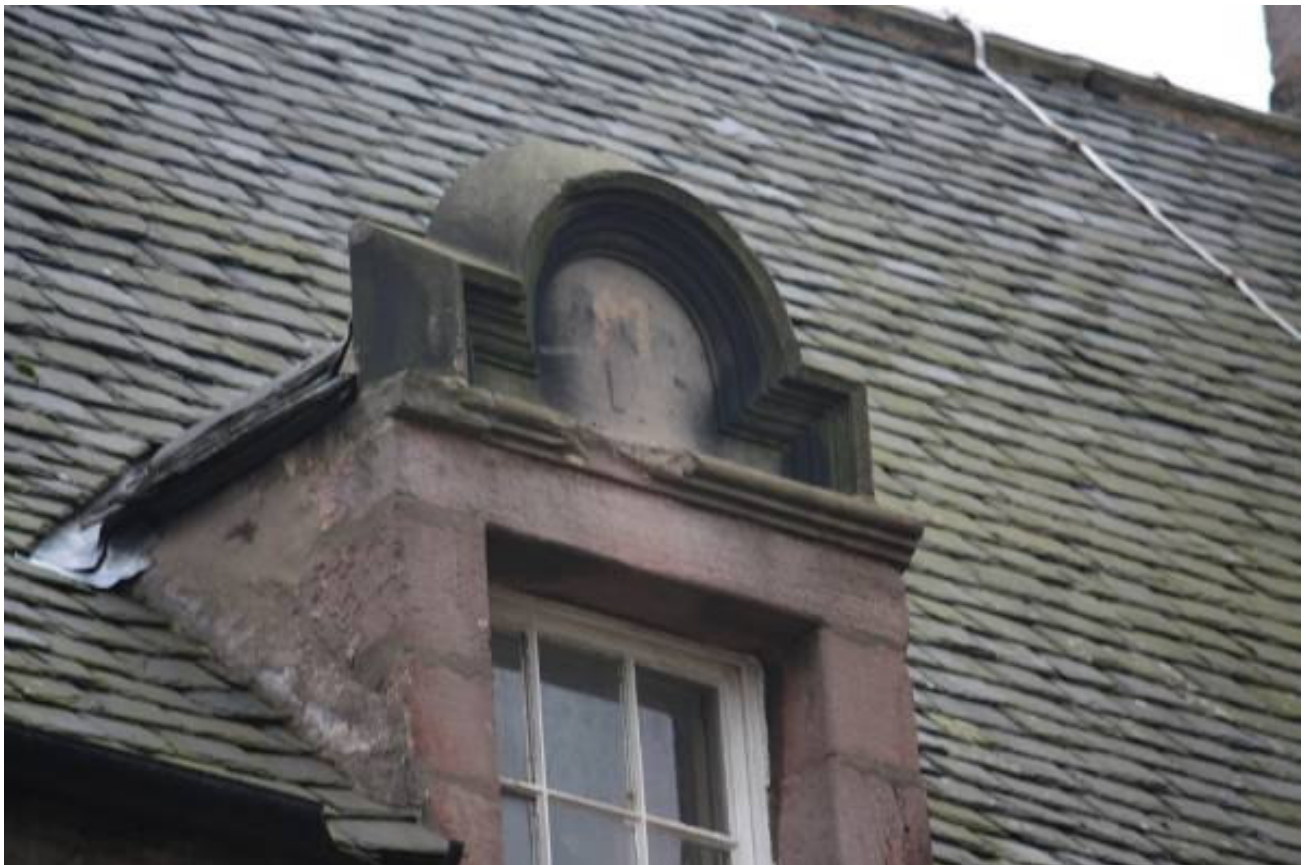
Lead flashing replaced with mortar around dormers

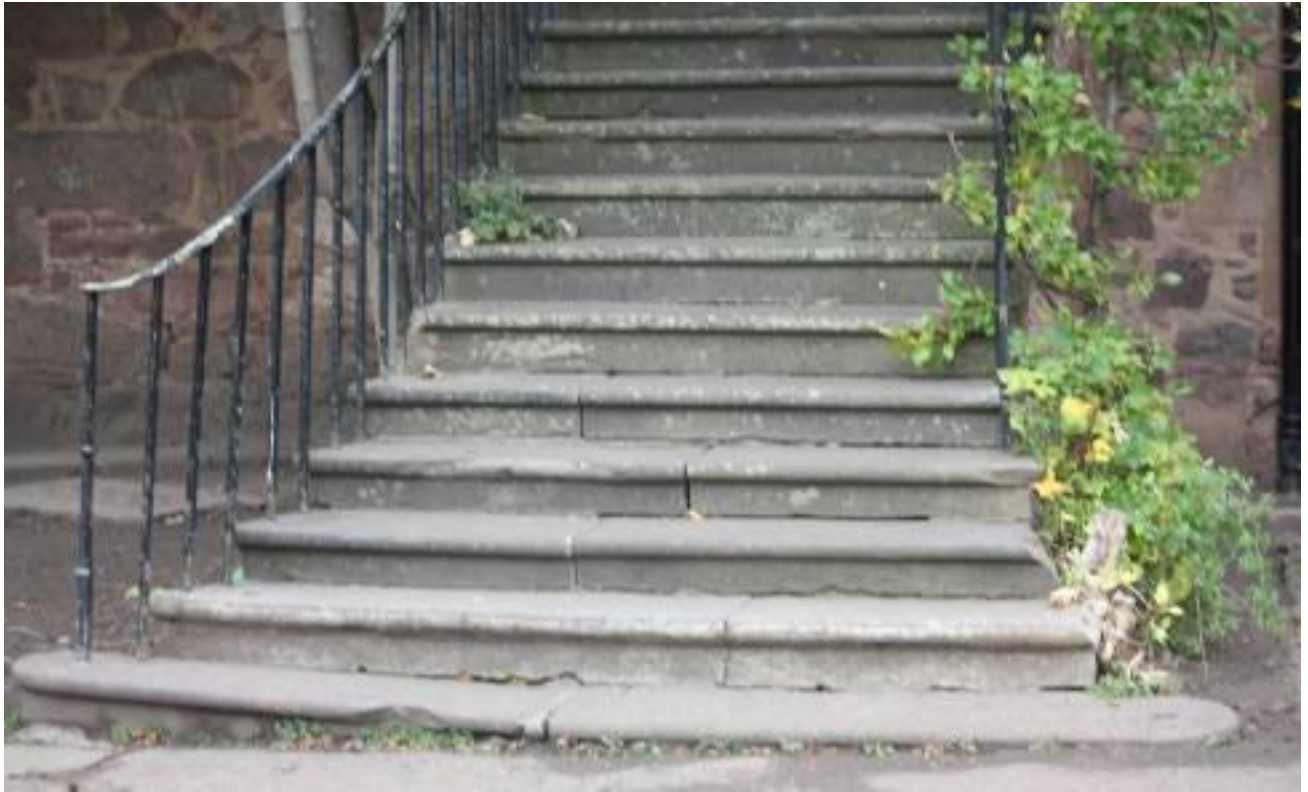
The stone staircase to the Rector's office on the west elevation is in need of serious repair as there are large areas of mortar and smaller stones missing. The wrought iron balustrade is also damaged and the lower section on the right hand side is also missing. The entrance door at this point is a modern 20th century replacement and should be removed. The door in this location should either match original or be simple and contemporary, as an honest replacement. The self seeded trees around this area of the north façade should all be removed and their stumps treated so as to prevent any regrowth. It is evident that these trees are beginning to cause some damage to the building, especially the stairs.

Staircase to Head Teacher's office showing damage to stone structure, steps and balustrades.

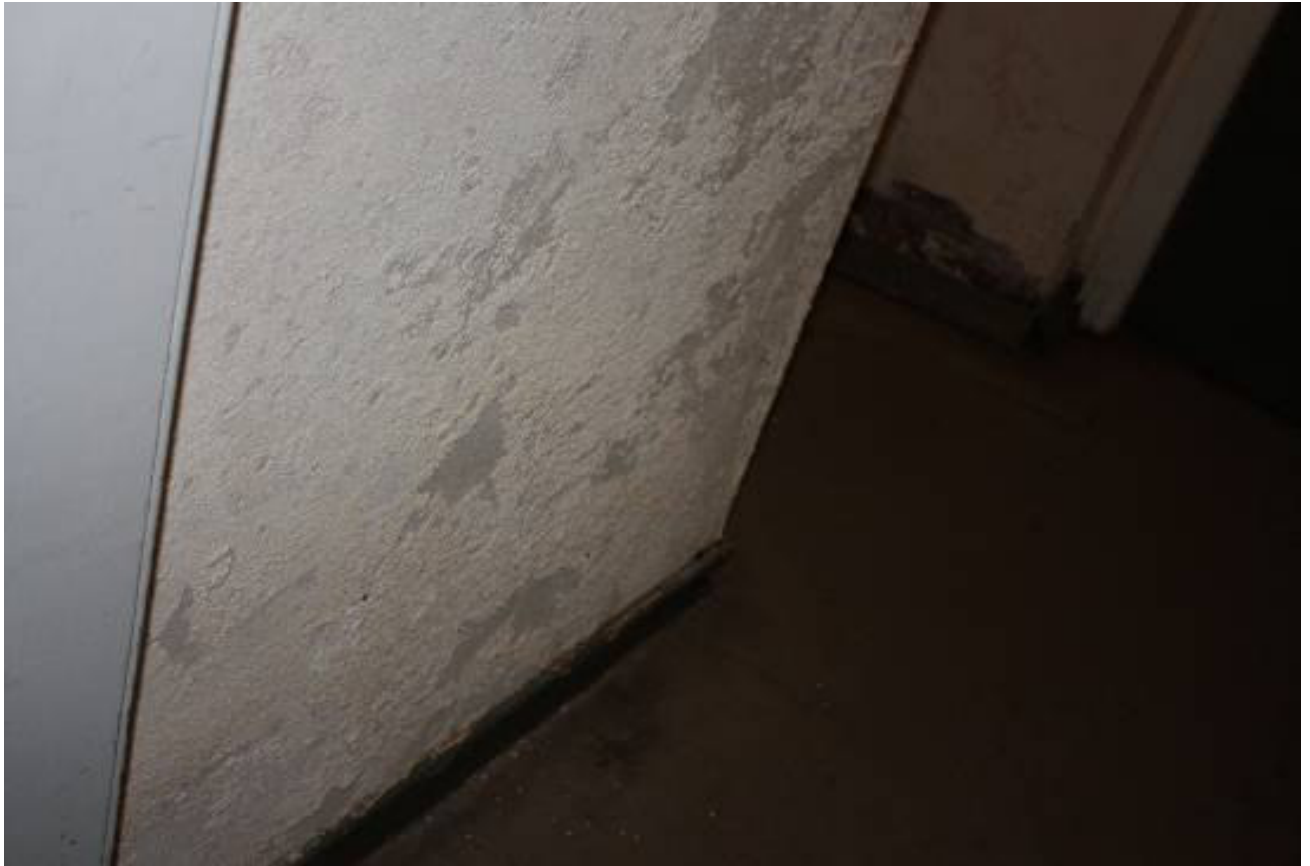
On the walls at the base of the later addition stairwell to the north there are serious signs of rot with the plaster falling of the walls. This needs to be investigated further and the walls made good.

Evidence of damp internally at ground floor

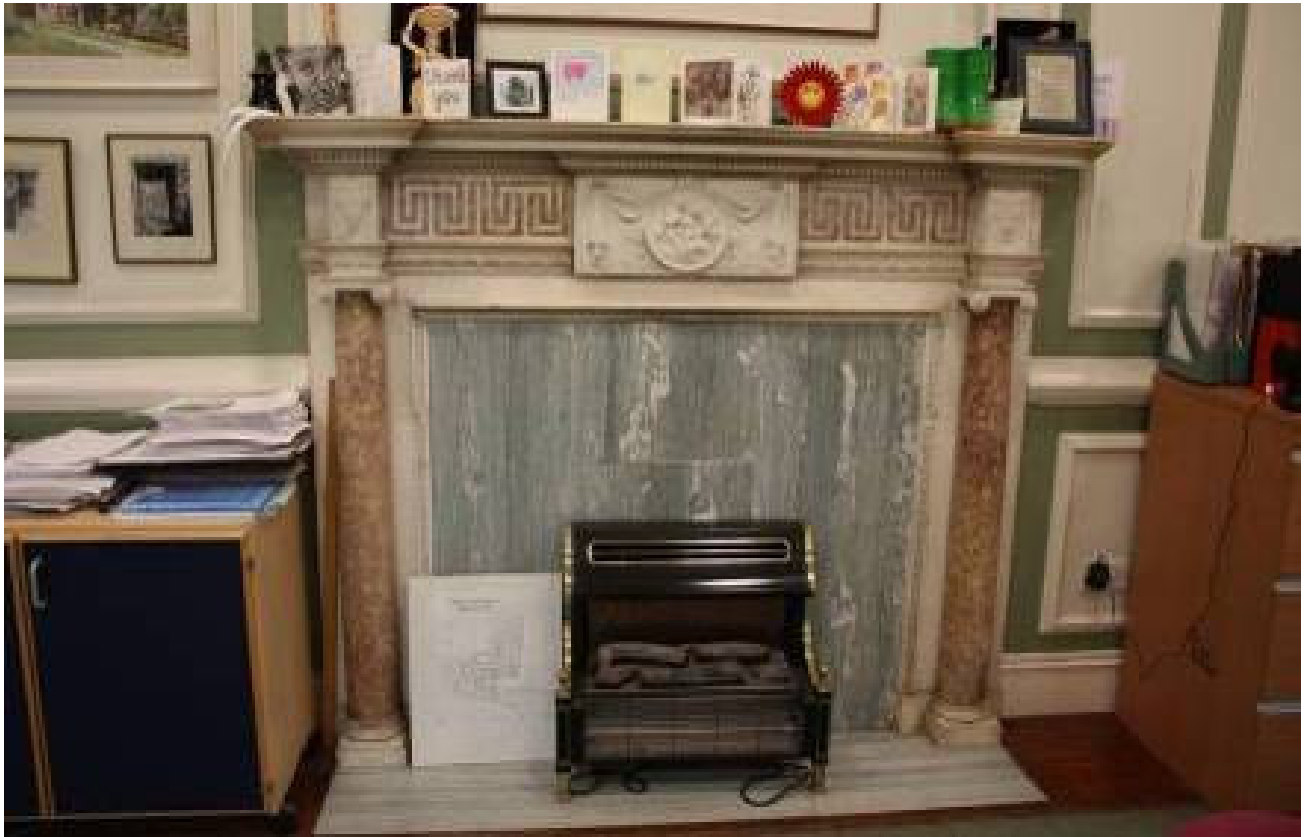
Each of the three main rooms on the first floor retains fine late 18th century marble fireplaces. These are in fairly good condition although the one in the deputy rector's room has sustained some damage. The one in the rector's room has had a later marble infill to the centre installed and a late 20th century freestanding fire fitted on the hearth. This fire is not in keeping with the building and should be removed. The fireplace should be opened up.

Fireplace in Head Teacher's office showing infill from 20th century electric fire

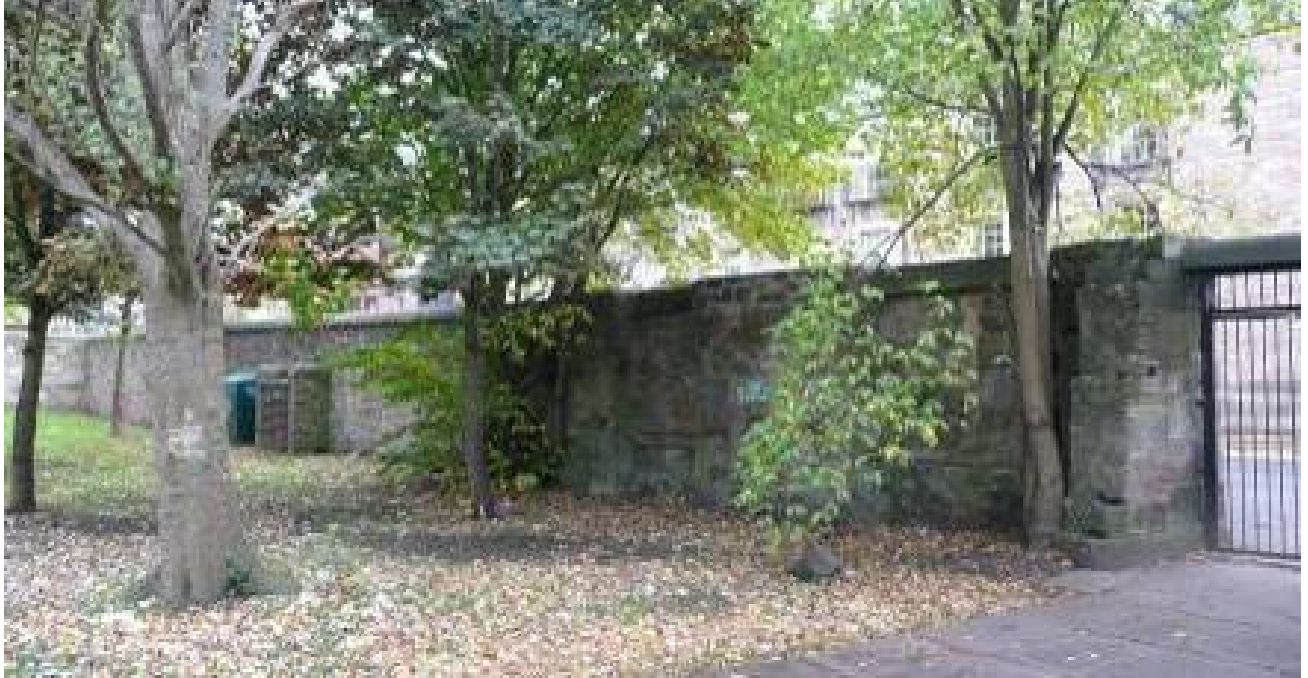
Moving northwards along this boundary there is evidence of a lodge or gatehouse by the main driveway. Some areas of wall in this location do not have a proper cope – it appears as if the walls of the building have been taken down to lintol level of the ground floor windows and door. The windows and door opening have been blocked up with stone. Its important to retain features like this, which give an indication of previous building on the site and therefore its evolution. In places this wall has areas of loose and missing mortar. There is also a self-seeded Whych Elm that is very close to this wall and requires to be removed or at least monitored to ensure its roots do not undermine the wall.

Whitehouse Loan boundary showing evidence of old lodge and issue with Whych Elm tree

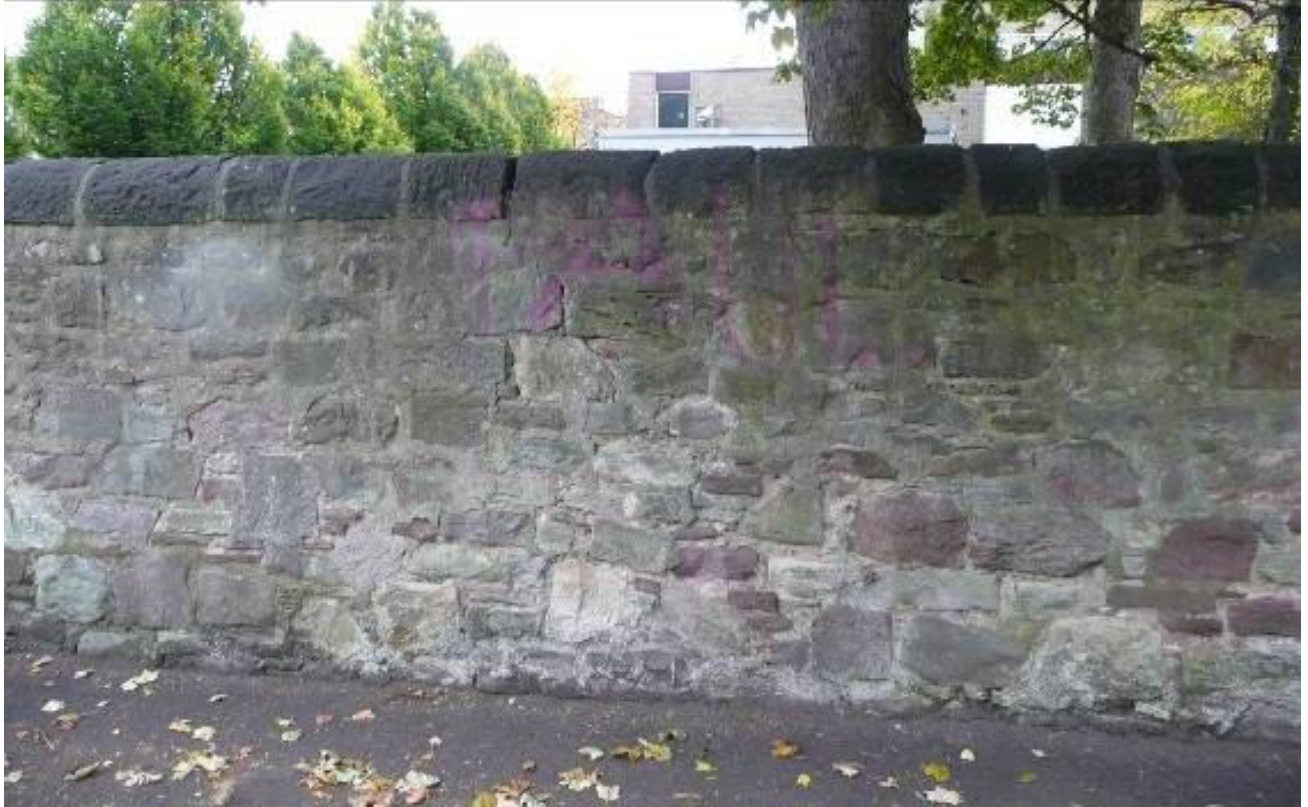
As this wall moves east there is evidence that it has been extensively repointed with a cement based mortar that has caused a disparity in weathering between it and the stonework. This is most evident in the upper areas that are predominately red sandstone. The mortar should be replaced with a lime based mortar and stones that have deteriorated need to be replaced or new cut in. There is an area of graffiti about halfway along its length that should be removed. There is also evidence that the mature Sycamore in this location has caused some movement in the wall. This should be monitored but at this stage there is no indication that it is of a level that would require the tree to be removed. The coping stones at this point have lost some of their mortar and would benefit from repointing.

Damage to stonework and copes on north boundary wall
