JAMES GILLESPIE'S HIGH SCHOOL CONSERVATION PLAN

DRAFT REPORT

03 December 2010

Prepared for The City of Edinburgh Council

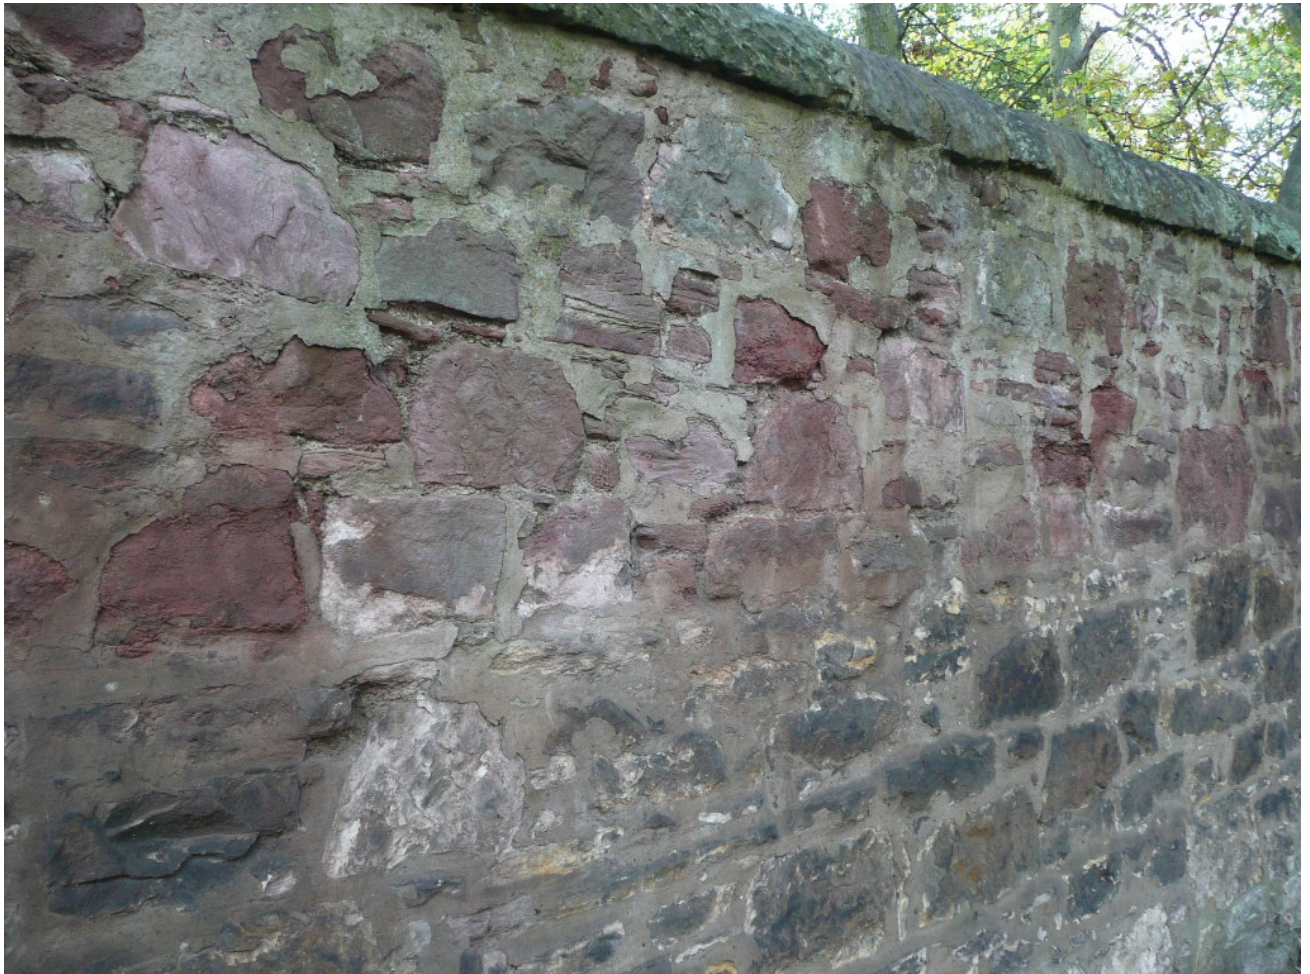
Damage to stonework and copes on north boundary wall

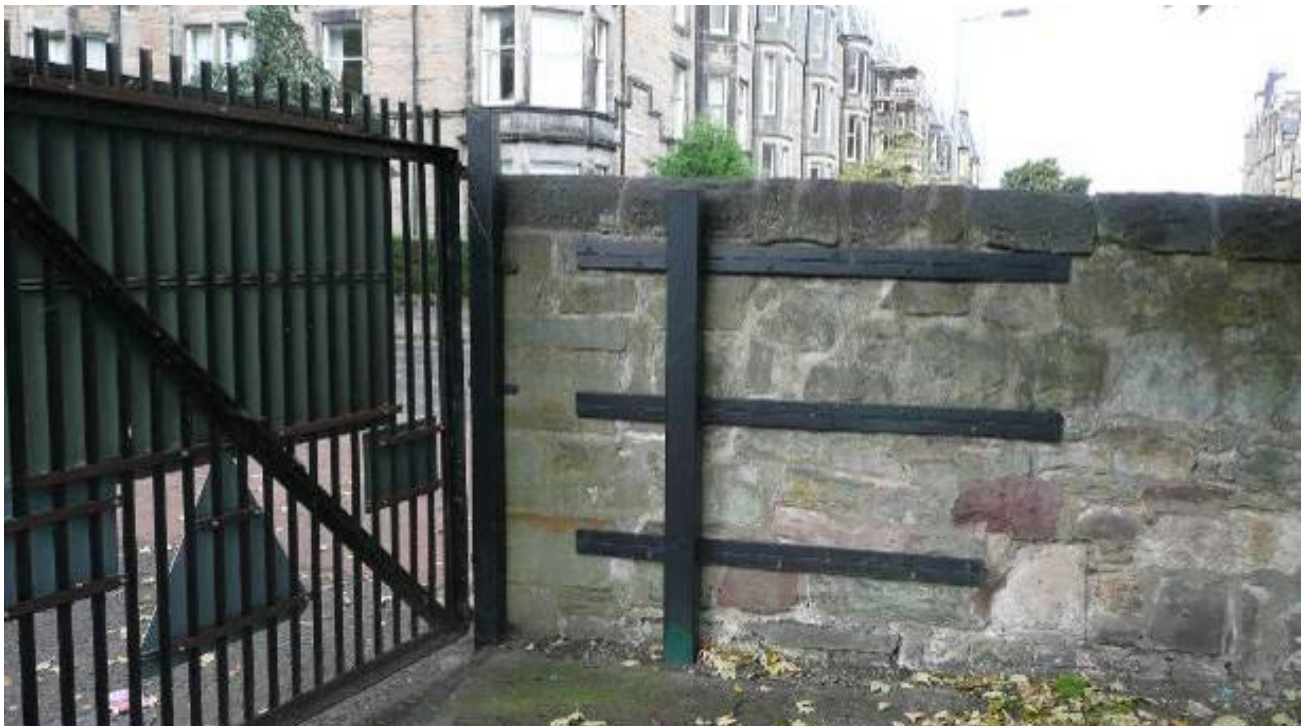
Metal straps to strengthen wall

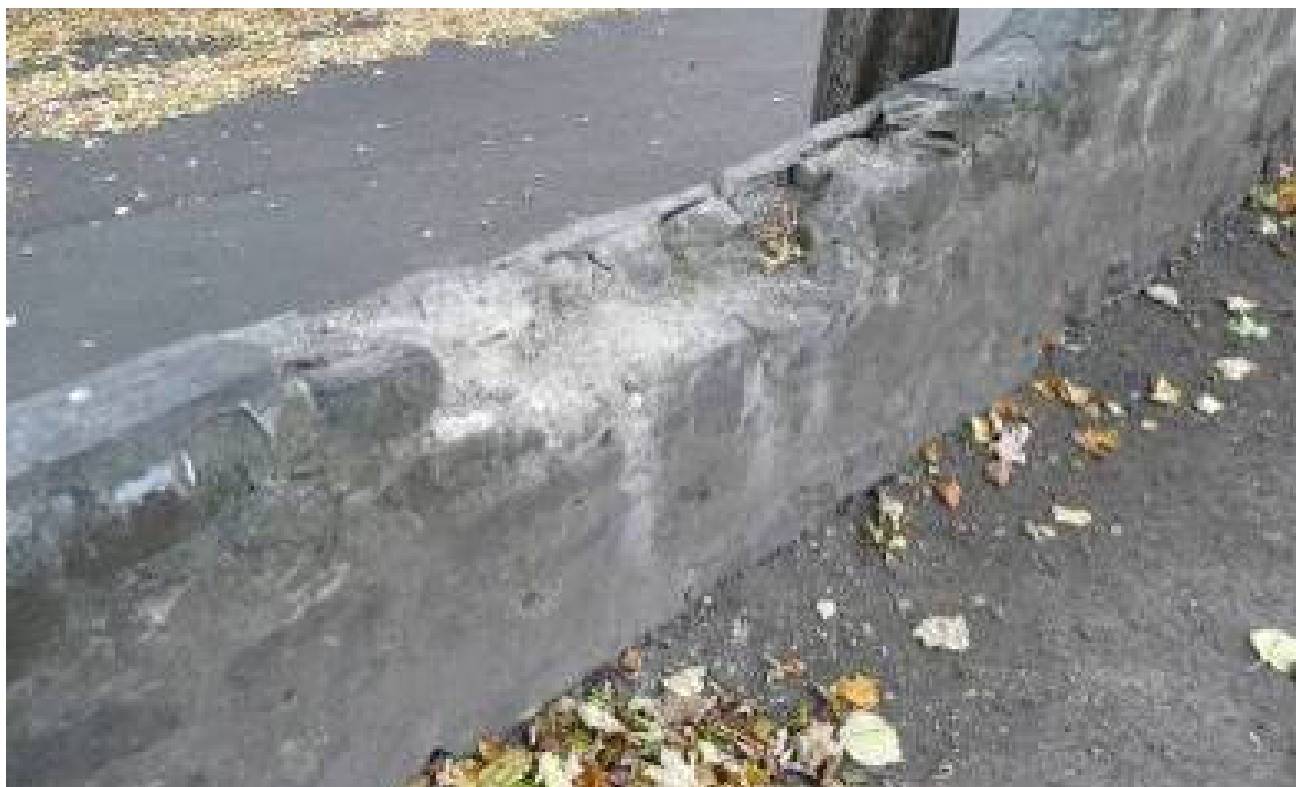
The wall that bounds the driveway to the school from Whitehouse Loan is a high coped rubble wall. They have an interesting pyramidal mortar cope detail. In areas this is deteriorating badly due to plant growth. The roots of nearby trees undermining it have also affected the wall. There are areas where there are stones and sections of cope missing. This needs to be repaired and new stones and lime mortar reinstated.

Missing stone and copes to driveway boundary

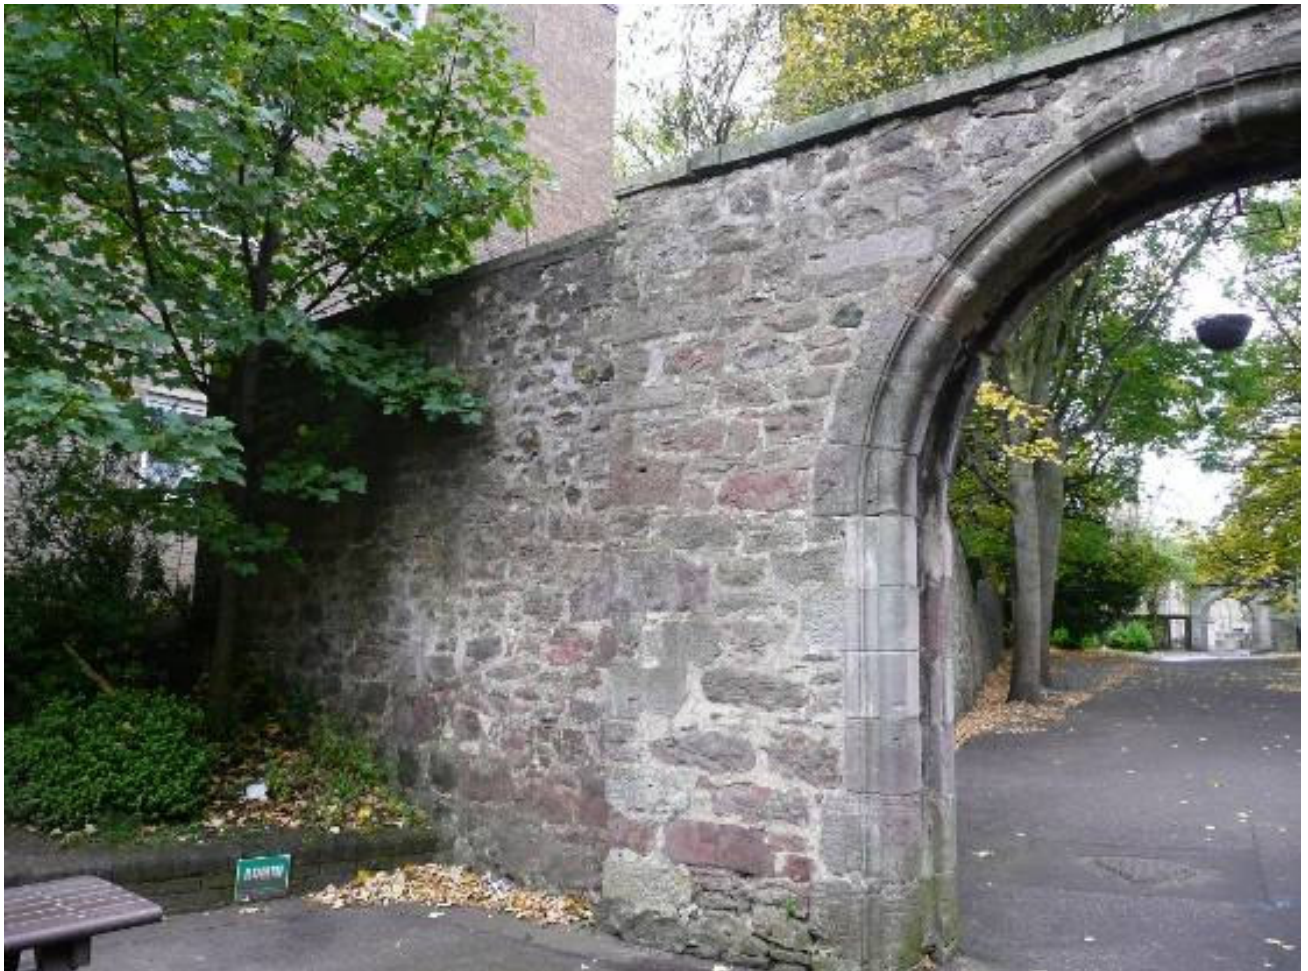
There is damage to some of the stones forming the archway at Bruntsfield House. These need to be repaired/ replaced and missing stone beneath the cope reinstated.

Damage to arch connecting to Bruntsfield House
