JAMES GILLESPIE'S HIGH SCHOOL CONSERVATION PLAN

DRAFT REPORT

03 December 2010

Prepared for The City of Edinburgh Council

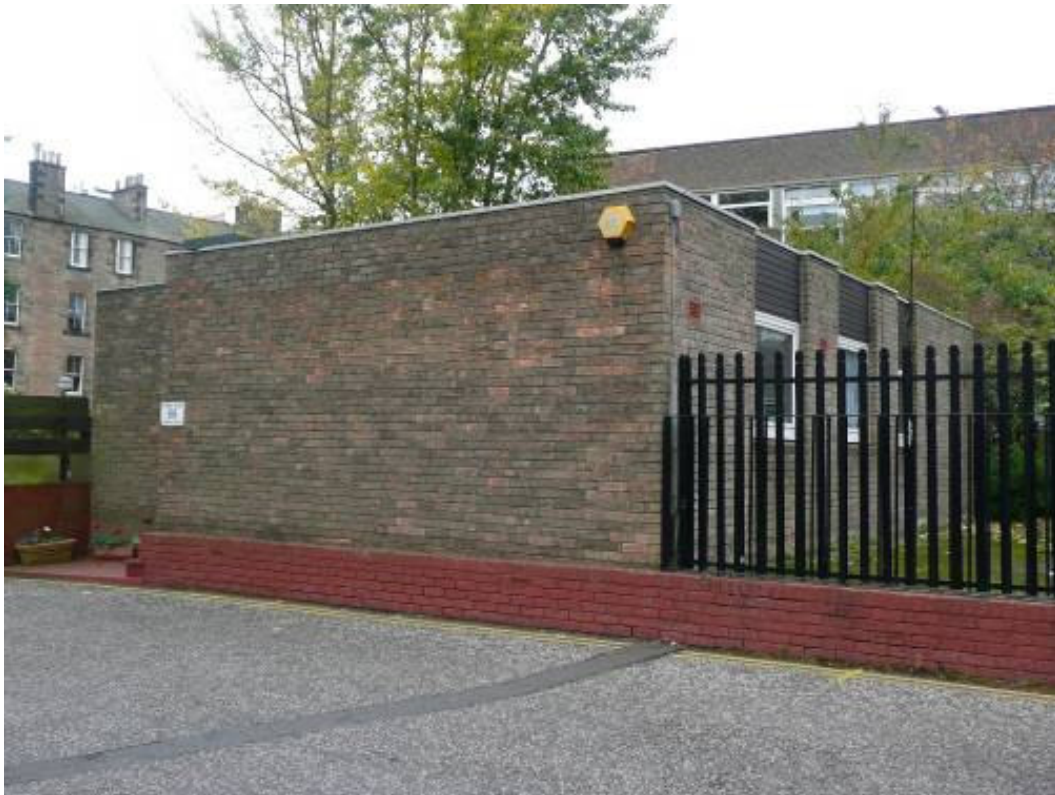
To the north of the site there is a 1970's nursery school with gym extension. The boiler house is one storey high but has a high chimney constructed from cylindrical concrete sections. These are all one storey and mainly examples of simple 70's aesthetic architecture. To the south east of the site is the janitor house. Originally this was a good example of 60's architecture but subsequent alterations to doors and boundary have reduced its architectural merit. It is constructed from load-bearing blockwork faced with brick.

Janitor's house in its current condition

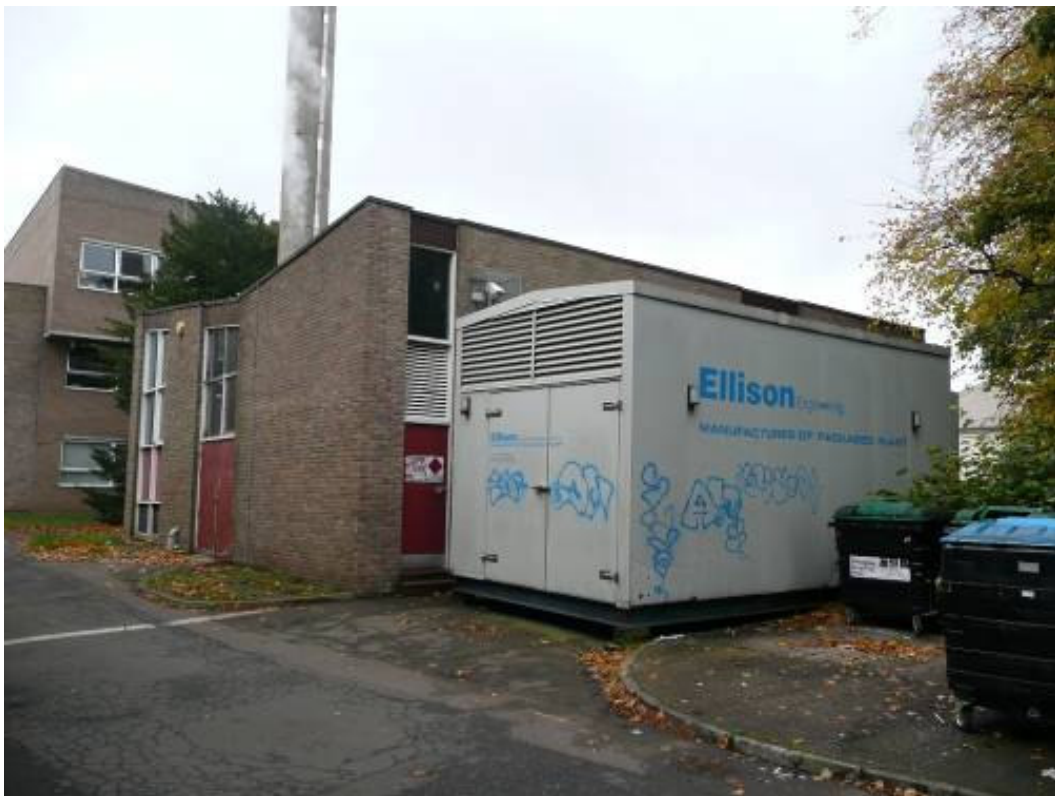
Boiler house in its current condition

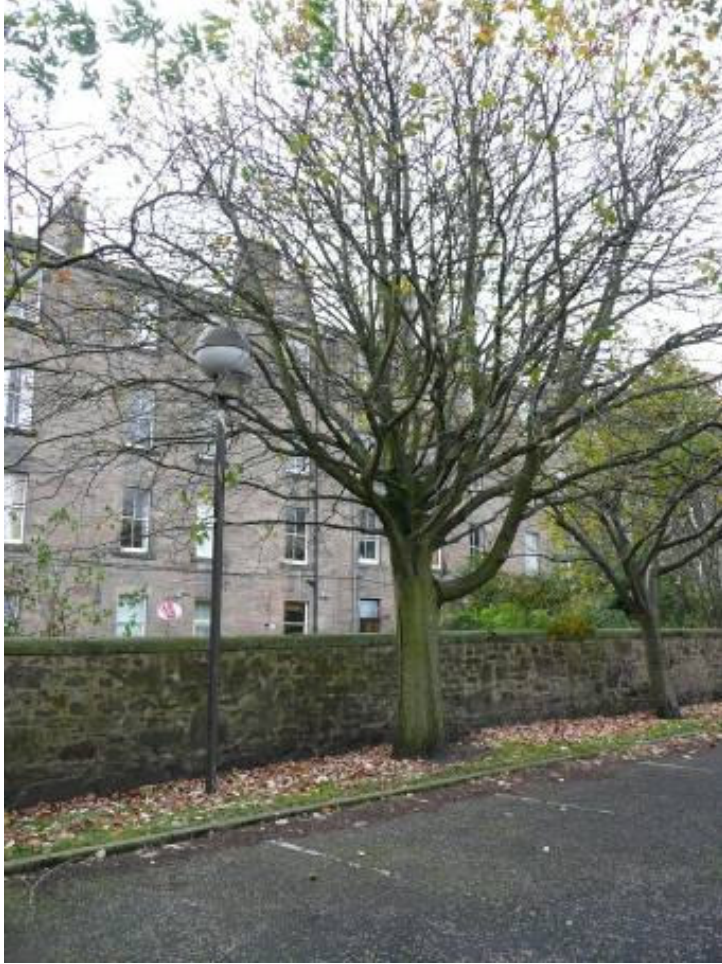
The boundary wall is significant not just to the site, but also to the surrounding areas, in particular in relation to views of the site from Bruntsfield Links. It changes its form along its length. The south of the site its is a typical tenement boundary wall. There are no immediate issues with its condition and it addresses the tenements rather than the site. It is approximately 1.8 m high and is formed from random rubble and mortar. It is not evident on the 1926 OS map, although the tenements are shown. It is assumed that this wall was constructed some time after the Second World War (as it is not in either of the 1940's aerial photos).

South boundary wall to tenement garden

The southern boundary, as it backs directly onto tenement gardens, is unlikely to be affected by any changes on the wider site. It should be maintained in good condition.

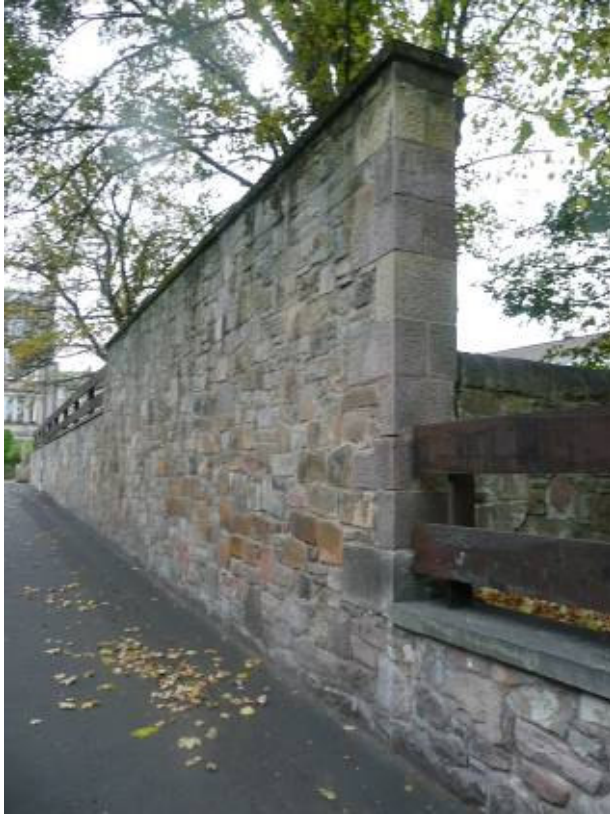
The Lauderdale Street boundary is later than the other main boundaries to the north and west. The first evidence of it is in the 1904 OS map. At its south end there is evidence of construction from older buildings as many of the stones are dressed and show indications of other features such as windows surrounds. In a couple of stones there are pieces of metal that look as if they were part of gate hinges or similar. It is much higher than any other areas of wall on this boundary and returns back into the site just beyond the higher level playground. This portion of wall should be retained where possible, as it is significant in the evolution of the site and also due to the materials used in its construction. The remainder of this wall is predominately low with wide timber board fencing above. This timber fencing is of no significance. Much of this wall is coped with concrete copes that have not aged particularly well. The copes to this area of wall should be replaced with real stone ones. The height of this boundary wall should not detrimentally affect views to Bruntsfield House.

High section of east boundary wall to Lauderdale Street

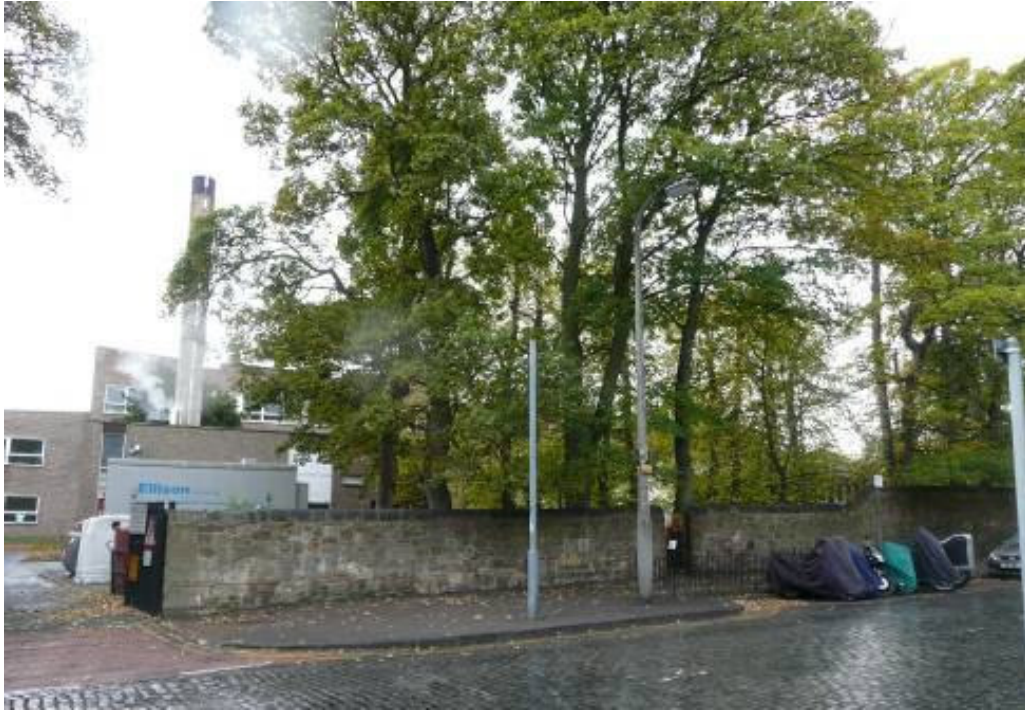
On Warrender Park Road the wall is lower to the east end, around the outdoor pitches, and then rises to full height at the west end around the primary school. It creates a good enclosure to the site in the context of the wider streetscape through its whole length. Along its length there are some instances of dislodged or missing stonework and where the entrance gate to the side of the sport pitch has been installed the wall is reinforced with steel posts and bars. The cope to this random rubble stone wall is half barrelled and its condition varies along its length. Towards the west end there is evidence of stone erosion due to the introduction of cement based mortar repairs. This is particularly evident to the areas where red sandstone has been used. In this area, at the junction with Whitehouse Loan, there is evidence internally of previous buildings on the site, by the paint finish on some of the stones and a vent on the street face.

North boundary wall to Warrender Park Road

The boundary walls to the north and west are of considerable importance, including their gateways. They should be retained and where gates are missing these should be replaced. The walls surrounding the driveway from Whitehouse Loan down to the stone arch by Bruntsfield House are also of considerable significance. They require repair to stop any further deterioration of condition. The arch and wall adjoining Bruntsfield House should also be retained/ repaired as it creates an important sense of enclosure to this corner of the house. To the north of the house the timber fence that splits the playground areas should be removed. Relocation of gateways or formation of new gateways would need to reuse existing gate piers or form new to match original.

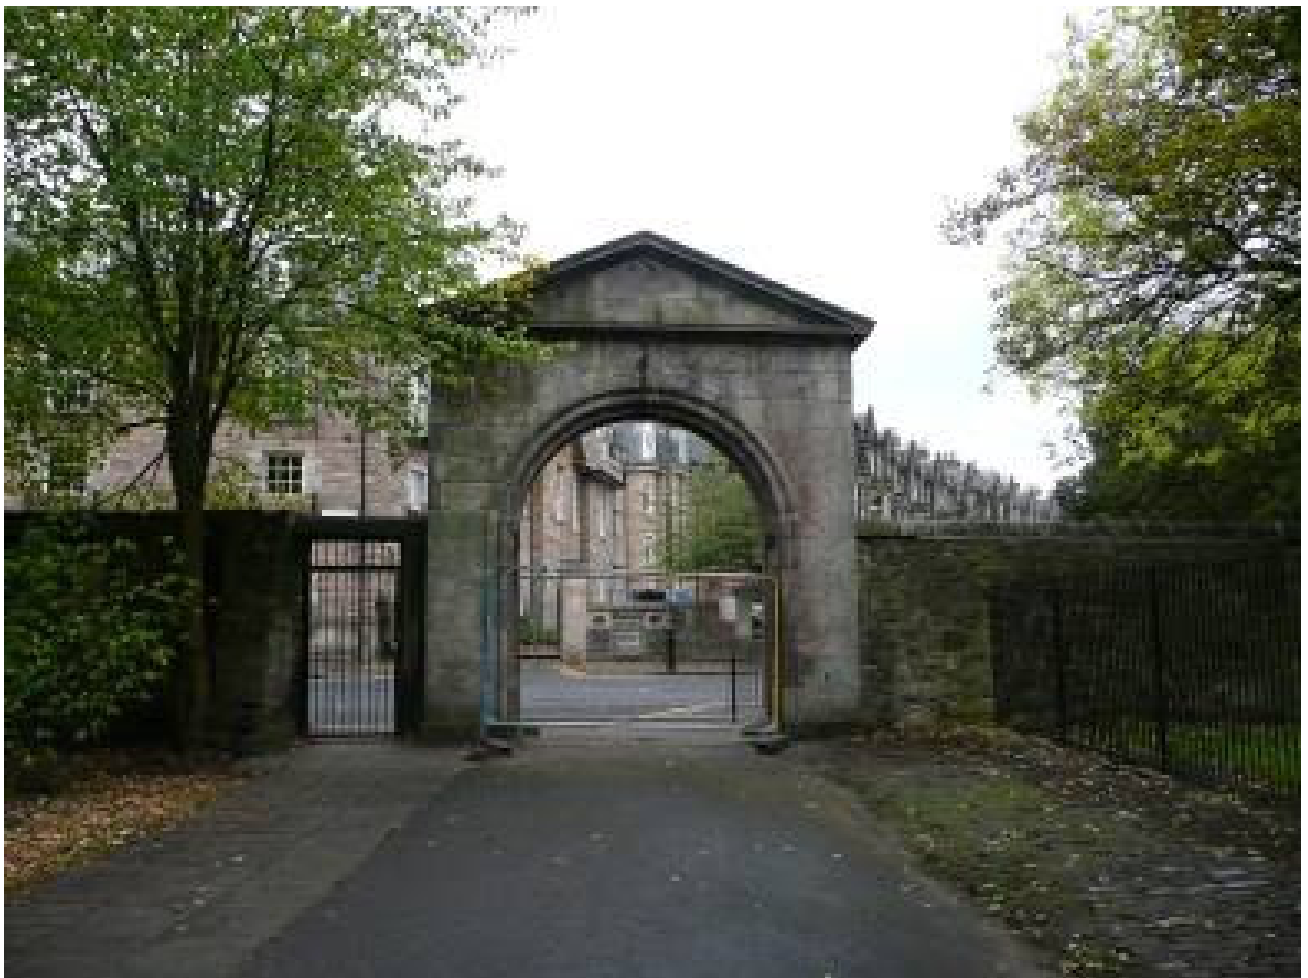
To Whitehouse Loan there are old stone carved panels integrated into the wall relating to the Warrender family. Items like this are important to the history of the site. The wall is at its highest along this elevation and provides a strong significant boundary to the site. There are three sets of gate posts to this street. The first gives entry to the side of the primary school and are formed by a pair of ashlar piers with pyramidal caps. The gates, although not original, are simple metal style and are in keeping with the site. The main entrance to the school driveway is heralded by a significant arched gateway. There are timber gates to this that are currently offsite for repair, although the wrought iron hinges remain. The gates are due to be reinstalled shortly. The top of the arch internally is showing signs of plant growth that should be removed before they start to affect the structure of the feature. Evidence of ferramenta should also be retained. It is likely that this was for a flag or light. The gate piers are pedimented round arched roll-moulded to the gateway. There is a pedestrian metal gateway in the wall at this location. Just to the south of this there is evidence in the boundary wall of a previous building, likely a gate house. The windows and doorway, although blocked up are still evident.

West boundary wall to Whitehouse Loan showing gateway

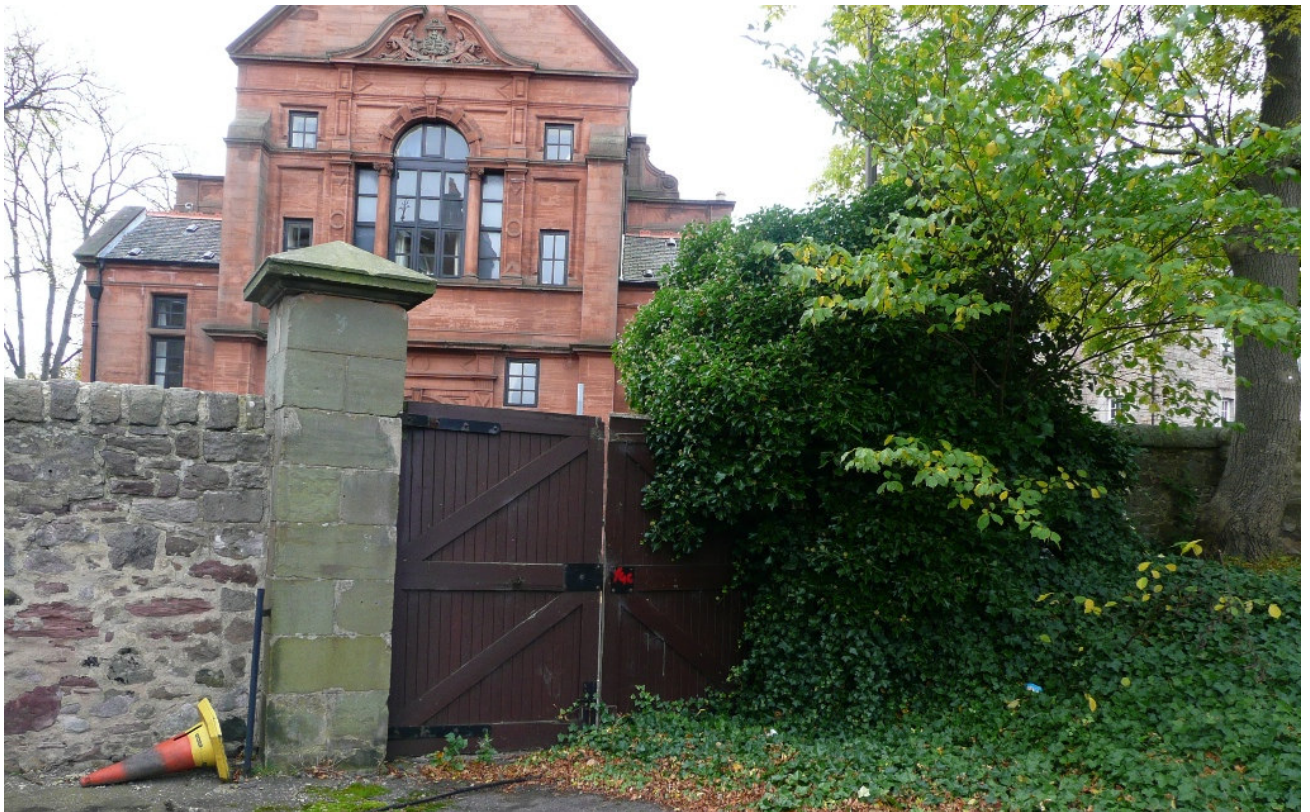
To the south of the Whitehouse Loan boundary is evidence of another gateway. It is not in use to the extent that to the side there is considerable ivy growth to the ashlar gate piers with pyramidal caps. Consideration could be given to reusing it in the future if required.

Disused gate to Whitehouse Loan

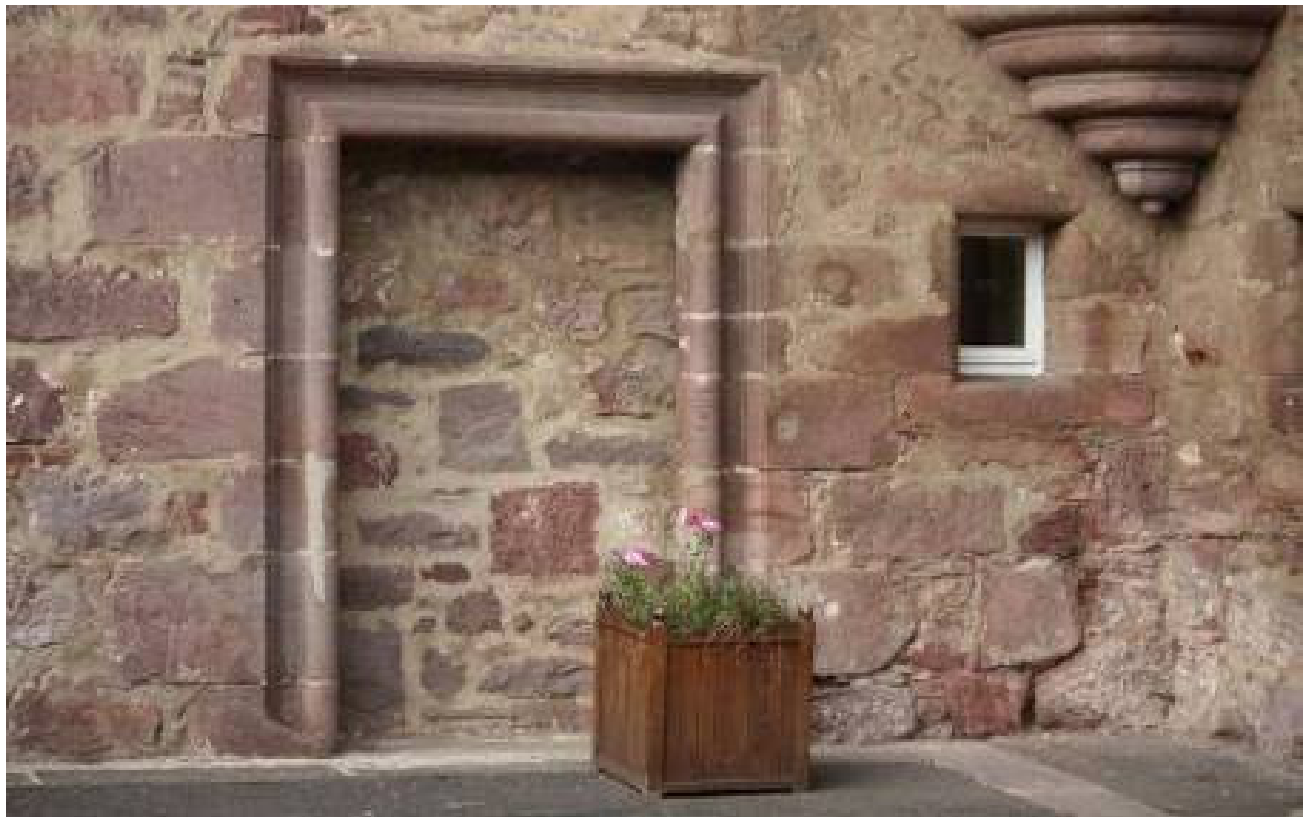
The original entrance door in the south east corner had been blocked up. Consideration should be given to reinstating this entrance. The current glazed entrance doors are no longer fit for purpose as they have large gaps around them that let in wind and rain. They should be replaced with either a doorway to match original or a new contemporary frameless glass system that is sufficiently water tight.

Original Doorway

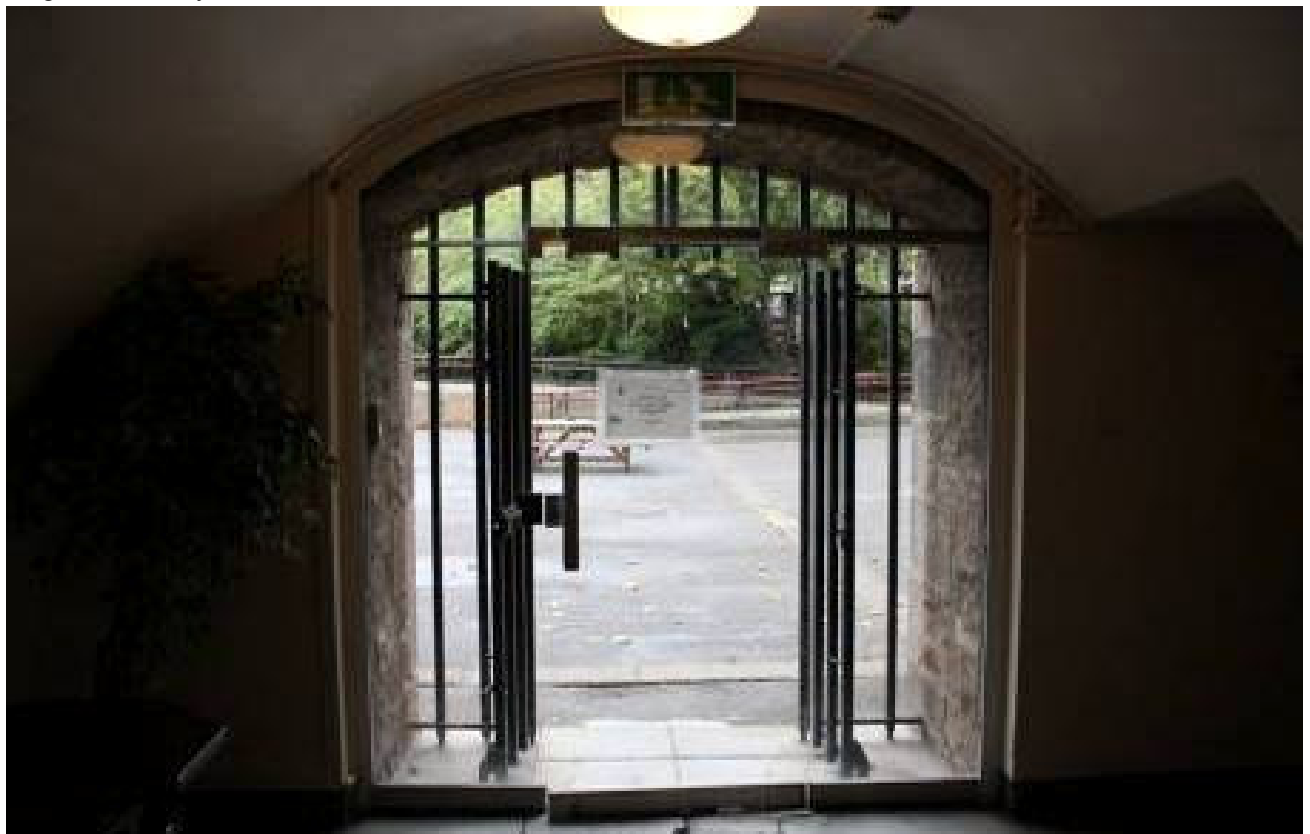
Later addition glass doorway with metal security gate to current entrance

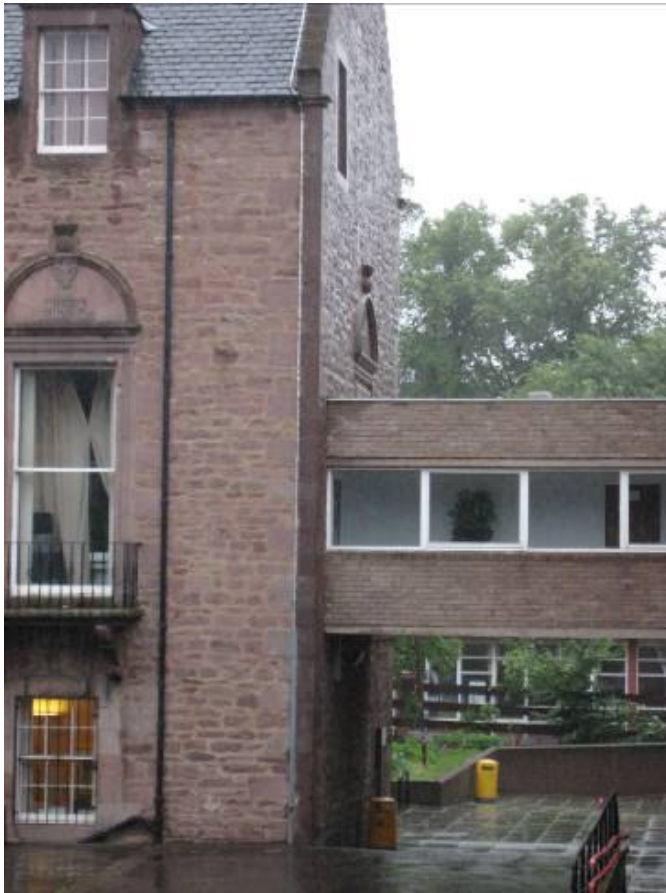
The link to the 1960's building should be removed and the sash and case window reinstated. Any link to Bruntsfield House should respect the architecture of this building and be of a system that does not damage the original structure and leaves it as visible as possible.

Link to Bruntsfield House

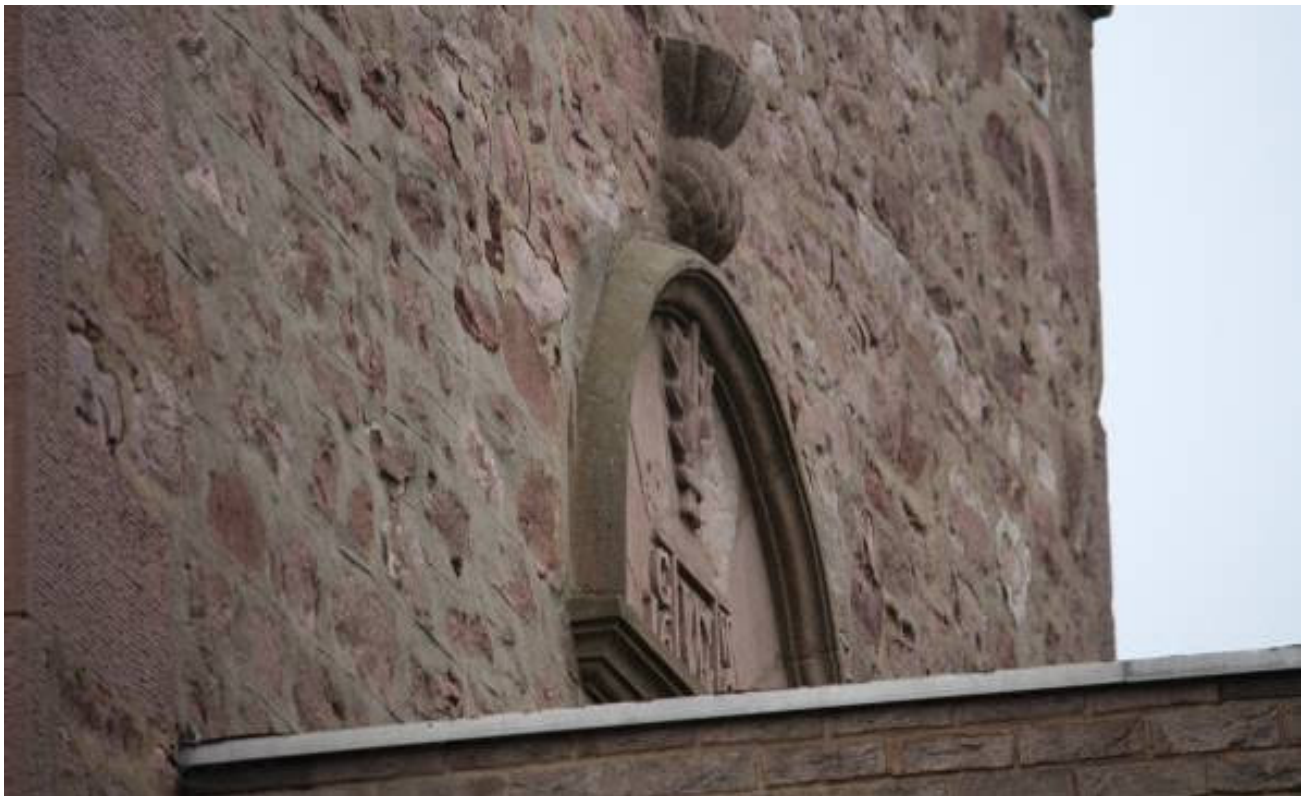
Original window surround visible above link

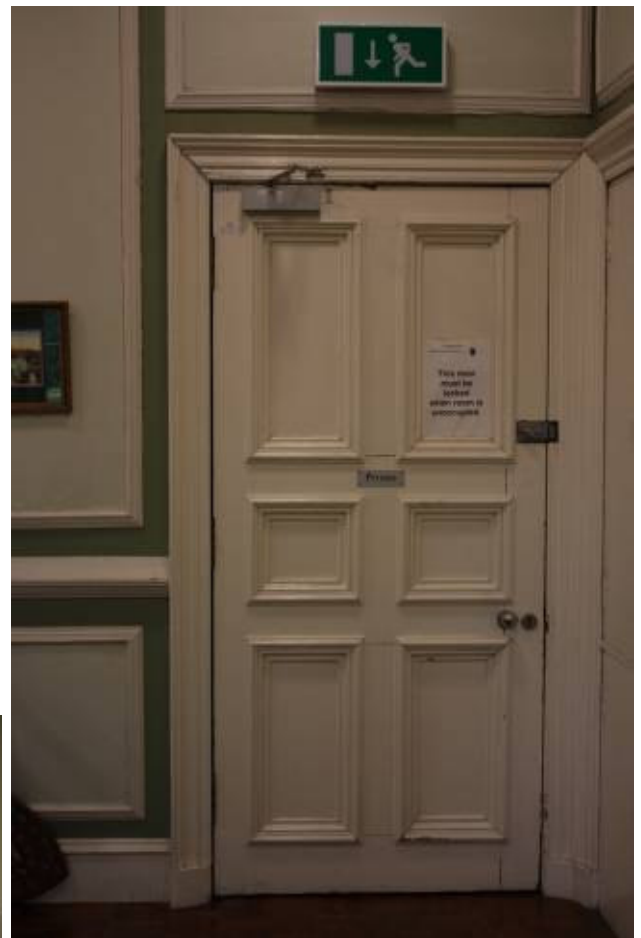
Internally to Bruntsfield House many of the original features have been lost. There are raised and fielded doors to the majority of rooms on the lower floors. The later addition 20th century door blanks should be removed and replaced in main areas with raised and fielded doors.

Raised and fielded door

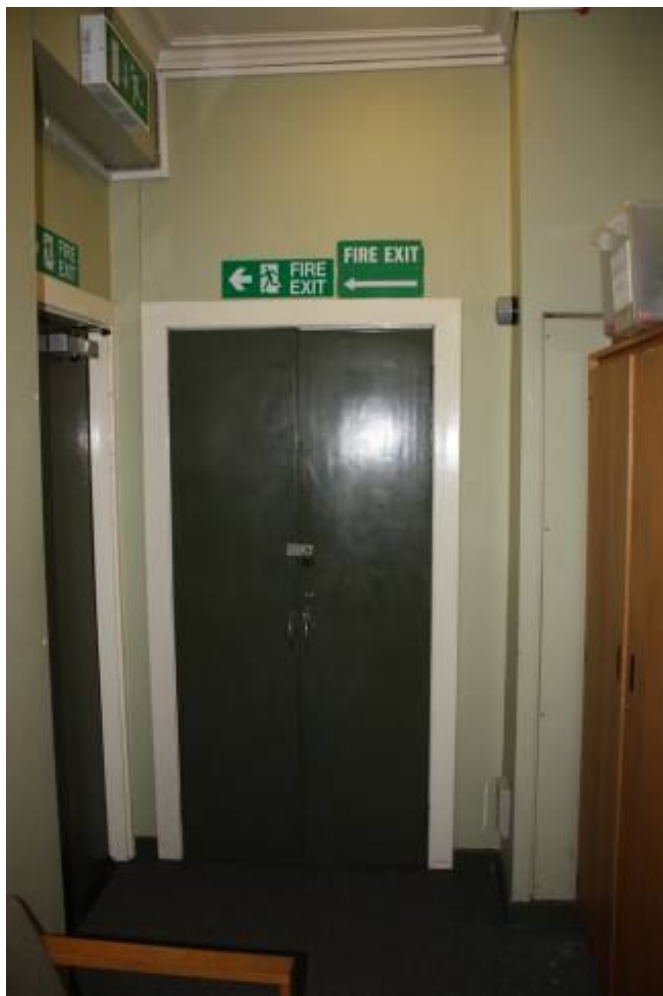
Door blanks

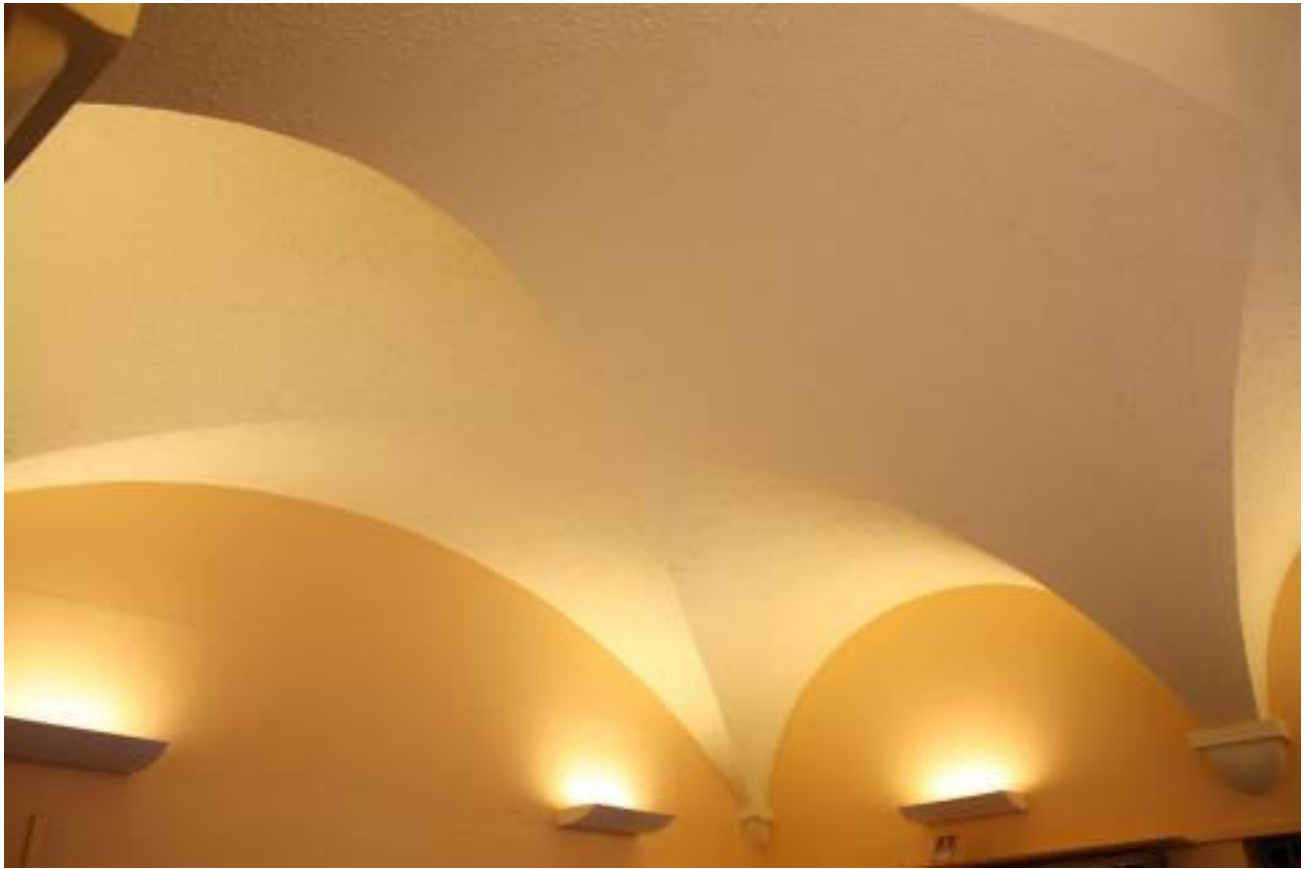
In the ground floor office there is a good example of a vaulted ceiling with corbels at the base of the vaults. The split of rooms has affected this and consideration should be given to reinstating this area as one room so that the ceiling can be viewed in its entirety.

Vaulting and corbels to ceiling – ground floor east wing

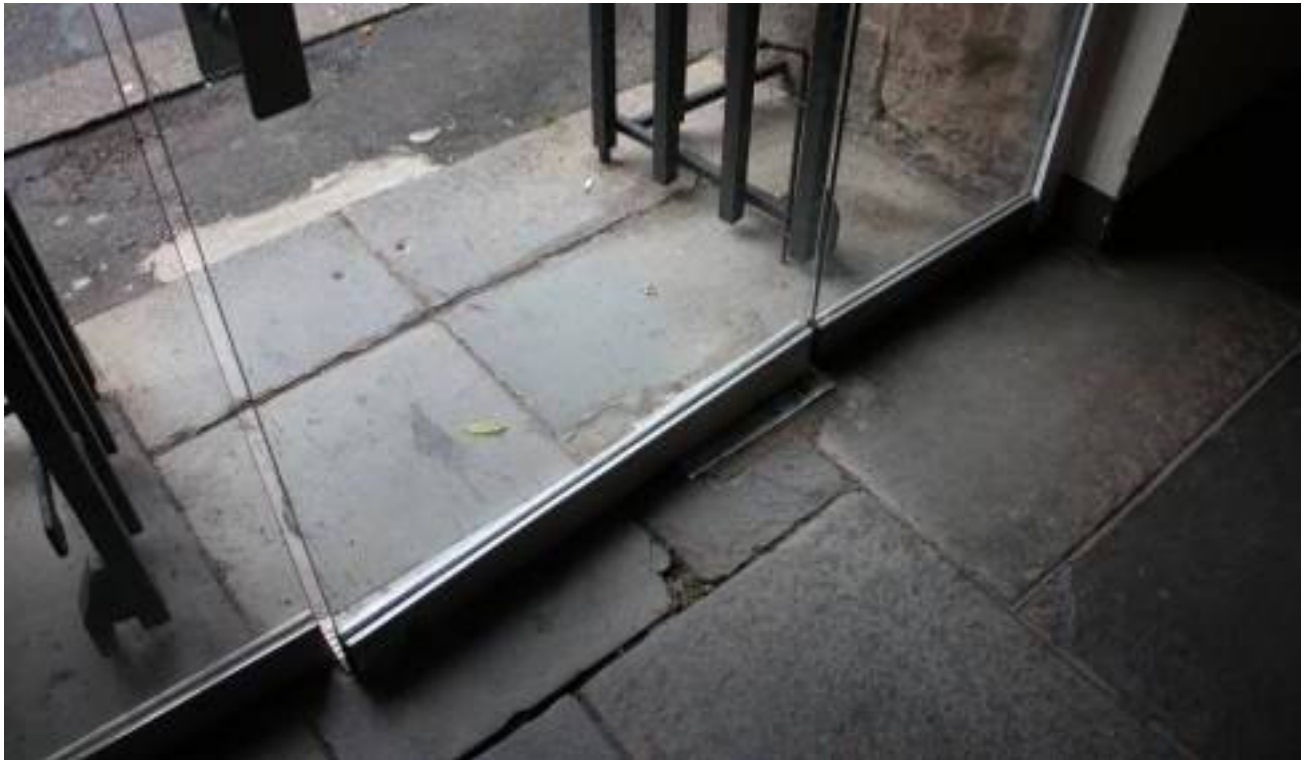
The stone flagstones in part of the ground floor are in good condition and should be retained. Within the current entrance hall there is a recent commemorative stained glass panel covering one of the original windows internally. It does not need to be in this location but should be retained in a prominent position within the building.

Stone Flags in ground floor

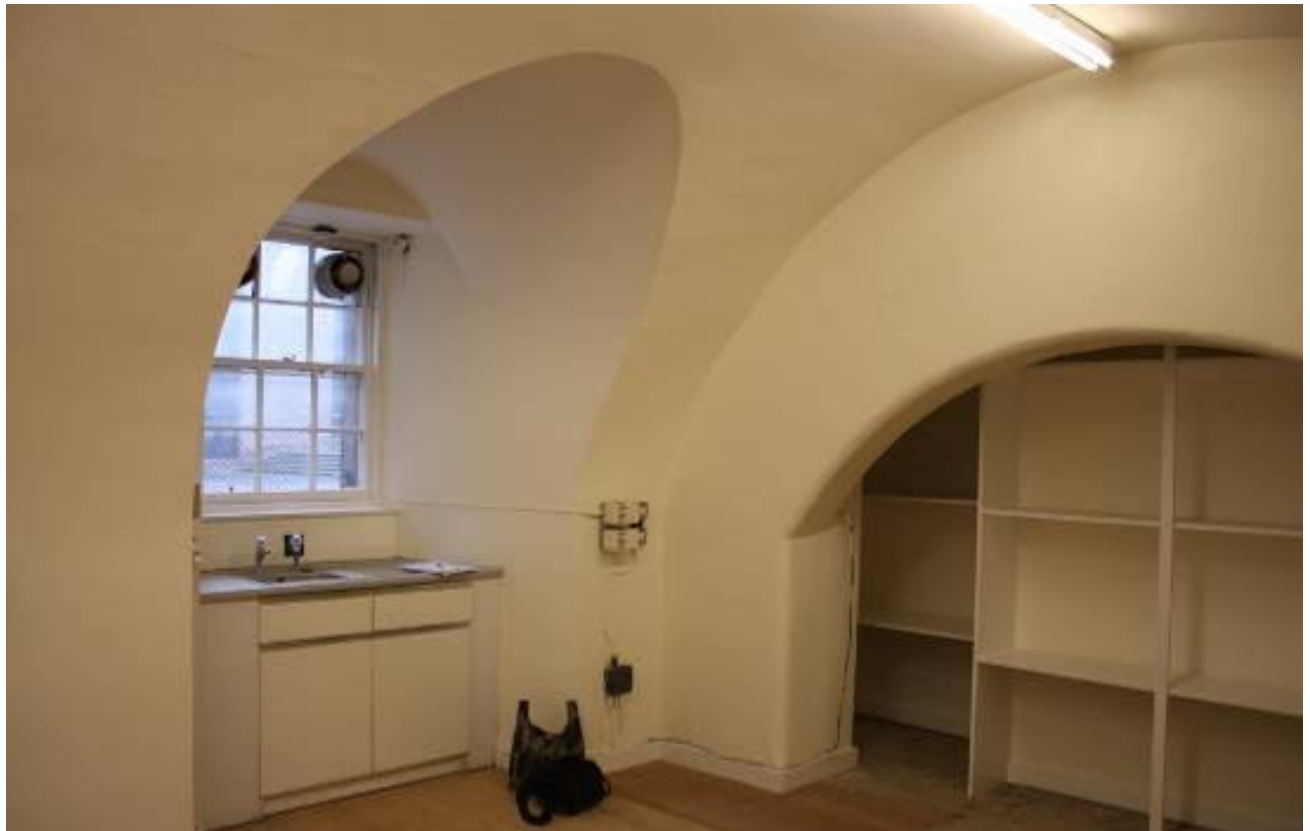
In the old kitchen the coffered ceiling and segmental- arched fireplace are still evident. These are significant and are to be retained. The 20th century shelving currently within the fireplace should be removed. In the ceiling in this location some of the plasterwork has been stopped to reveal the original stone vaulting. Features like this should not be covered over.

Vaulted ceiling and segmental arched fireplace in old kitchen

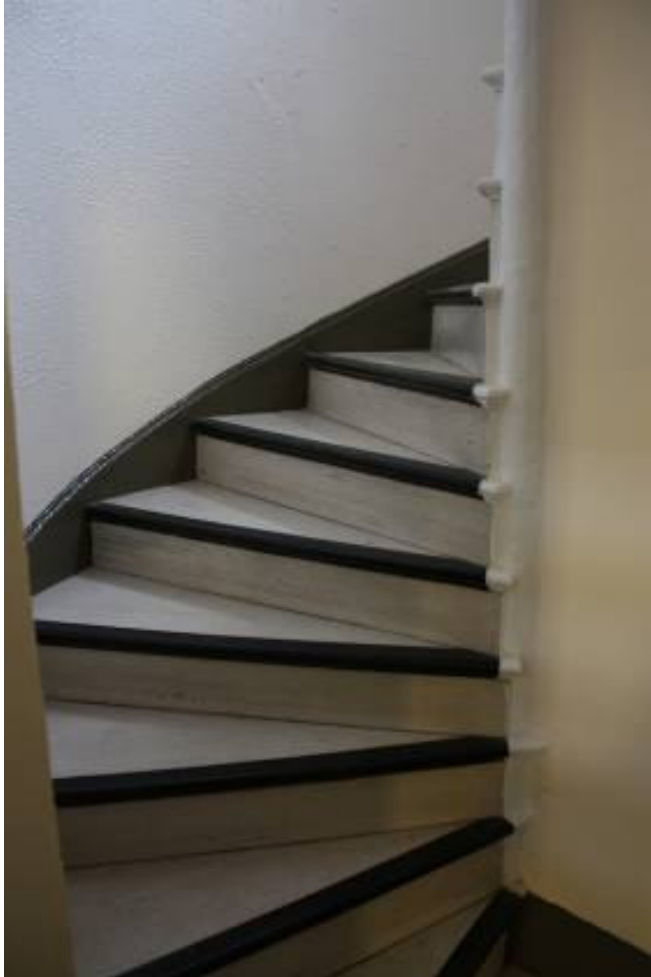
Spiral stair to south

There are two original stone spiral staircases. One has vinyl floor tiles adhered to it and these should be removed and the condition of stonework below assessed. The other has been painted and this paint should also be removed to reveal the original stonework below. Use of this material is not in keeping with the history of the house and detracts from this original feature. Both have thin metal handrails that should be retained. The two other staircases in the building are non original. The metal staircase to the south west has no architectural significance and its industrial aesthetic is not appropriate in a building of this age. It should be removed and if required to be replaced a new stair should be reinstated that is of a more robust material and aesthetic.

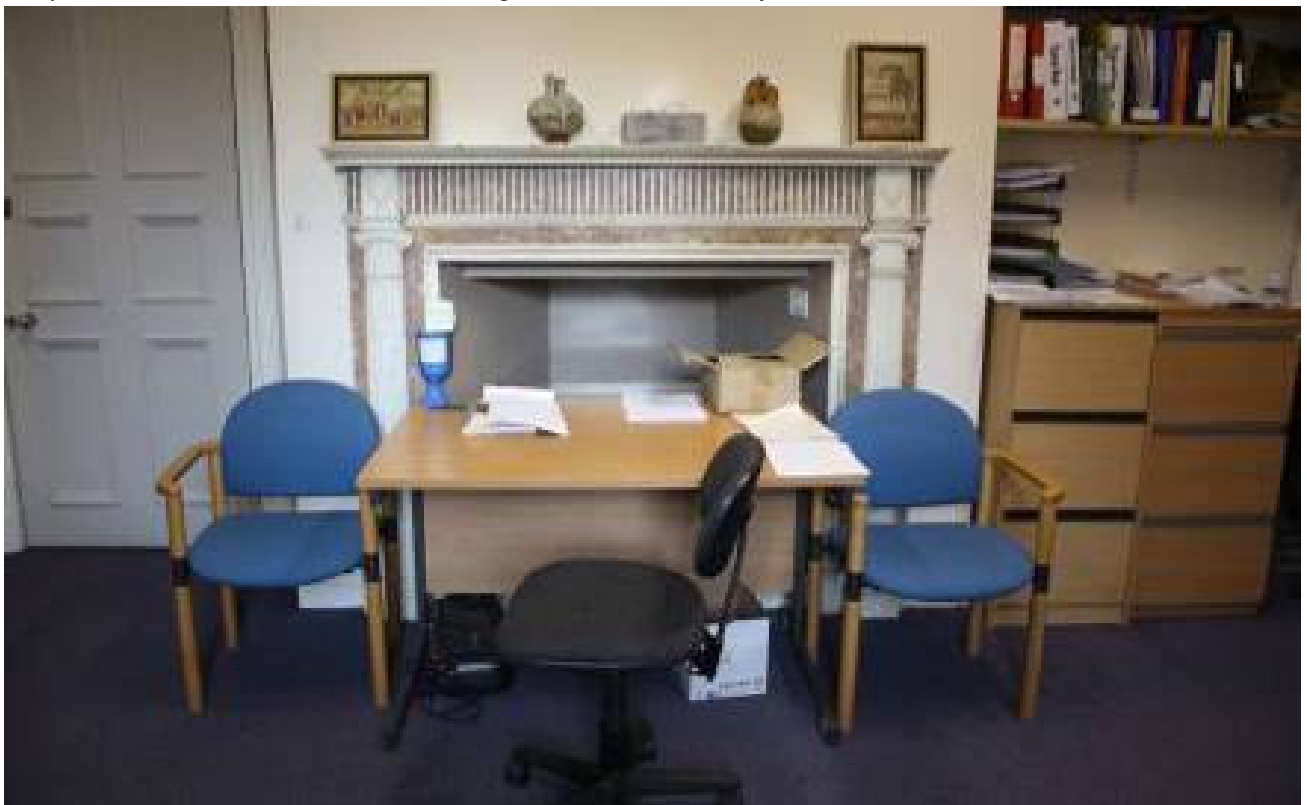
Each of the three main rooms on the first floor retains fine late 18th century marble fireplaces. These are in fairly good condition although the one in the deputy rector's room has sustained some damage. The one in the rector's room has had a later marble infill to the centre installed and a late 20th century freestanding fire fitted on the hearth. This fire is not in keeping with the building and should be removed. The fireplace should be opened up.

Fireplace in deputy rector's office which has areas of chipping to marble

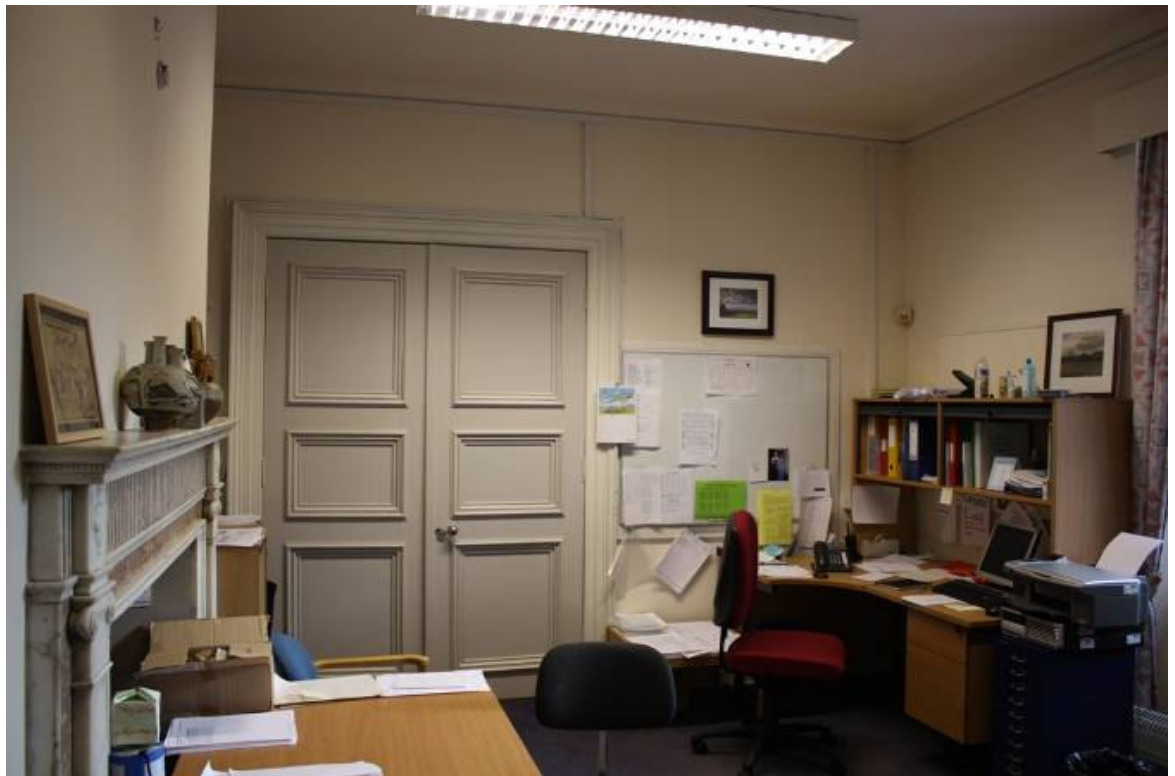
There are double doors separating these three rooms that are raised and fielded with panelling in the small lobbies between. The most easterly of these has been blocked up to form a cupboard. This cupboard detracts from the architectural significance of these rooms and should be removed, reinstating the doors and panelling.

Double door separation blocked off behind to form cupboard

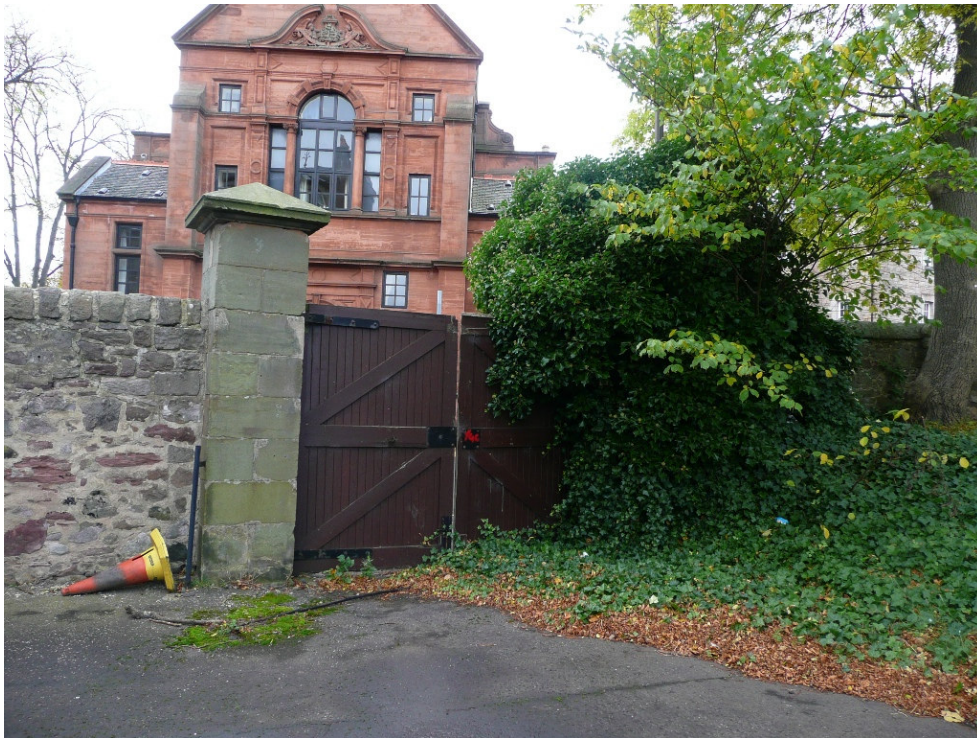
On the Whitehouse Loan wall the furthest south gateway is not in use. The ashlar gatepiers with pyramidal caps have timber gates that are in a poor state of repair. There is ivy growth to the internal face of these. This plant growth should be removed and the condition of the stone and mortar assessed. Adjacent to the pier there are areas of loose stonework, and many of the edges to the dressed stone of the piers are chipped and damaged.

Disused gateway, Whitehouse Loan

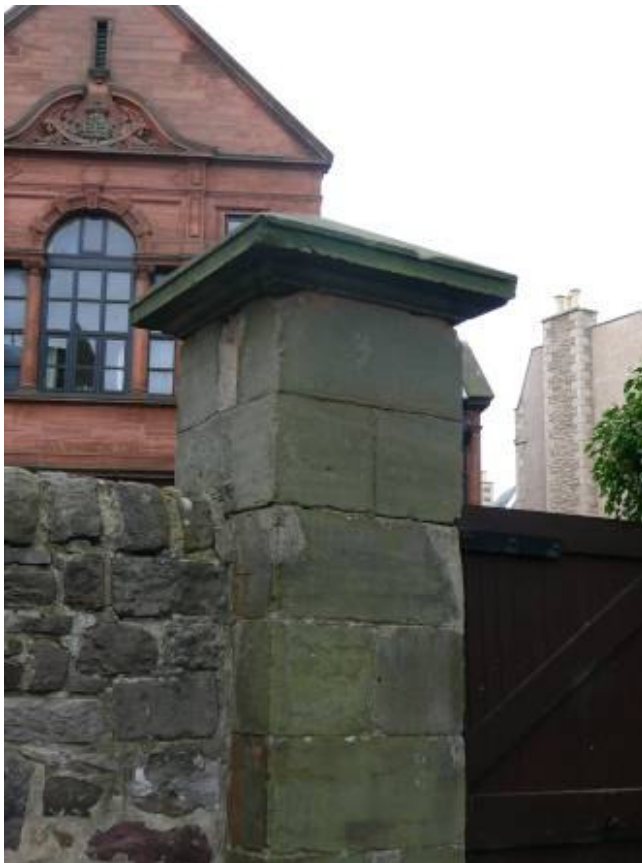
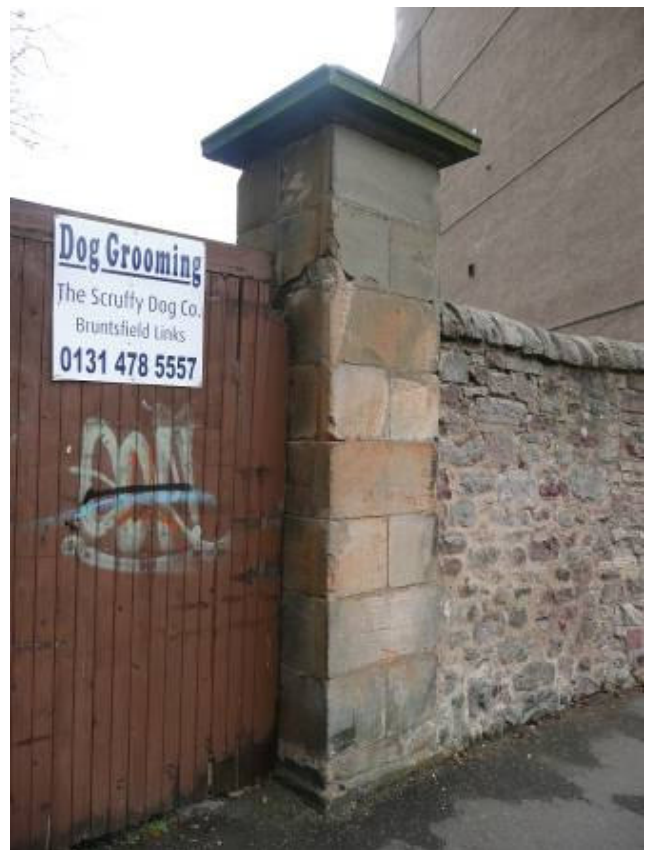
Damage to ashlar gate pier

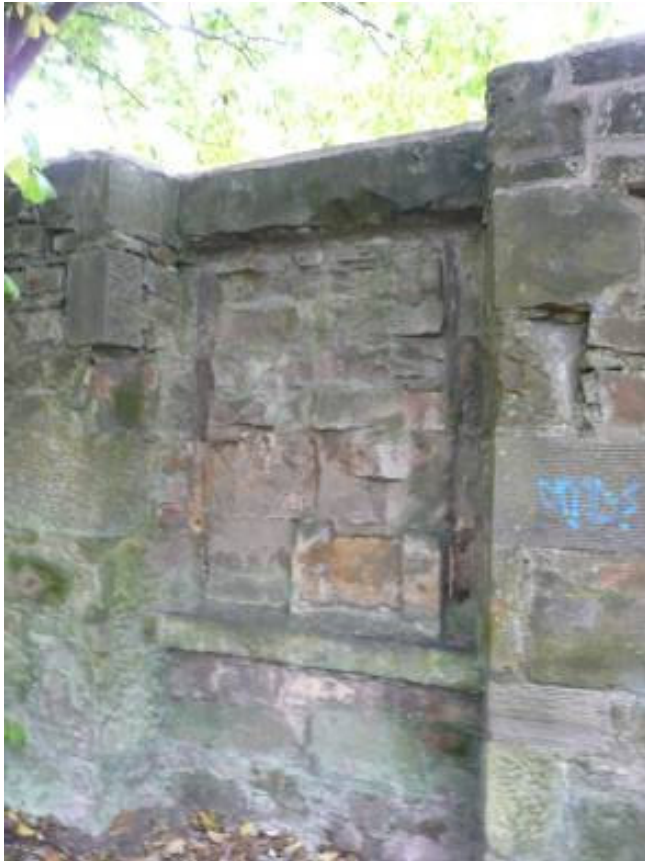
Graffiti to wall

There is evidence of graffiti on this wall that should be removed to prevent encouraging any further vandalism. The main gate, noted in the Historic Scotland listing as being a studded timber gate with wrought iron hinges, is missing. This should be reinstated. The head of the pedimented round arched roll moulded gateway had plant growth on the school side that should be removed. The metalwork should be retained and brushed down and repainted to prevent further deterioration. The painted metal pedestrian gate is not original, but is of a simple design and can be retained.
