JAMES GILLESPIE'S HIGH SCHOOL CONSERVATION PLAN

DRAFT REPORT

03 December 2010

Prepared for The City of Edinburgh Council

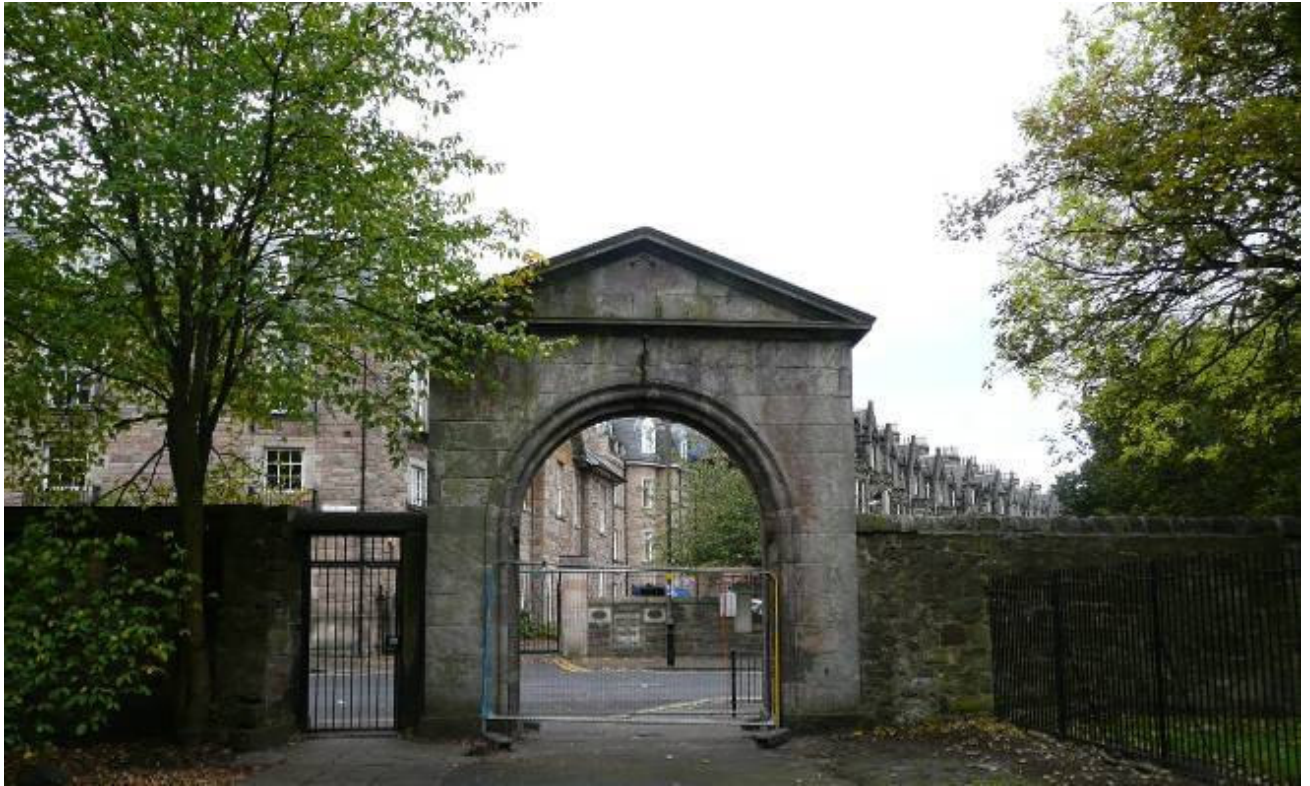
There is evidence of graffiti on this wall that should be removed to prevent encouraging any further vandalism. The main gate, noted in the Historic Scotland listing as being a studded timber gate with wrought iron hinges, is missing. This should be reinstated. The head of the pedimented round arched roll moulded gateway had plant growth on the school side that should be removed. The metalwork should be retained and brushed down and repainted to prevent further deterioration. The painted metal pedestrian gate is not original, but is of a simple design and can be retained.

Gateway as existing

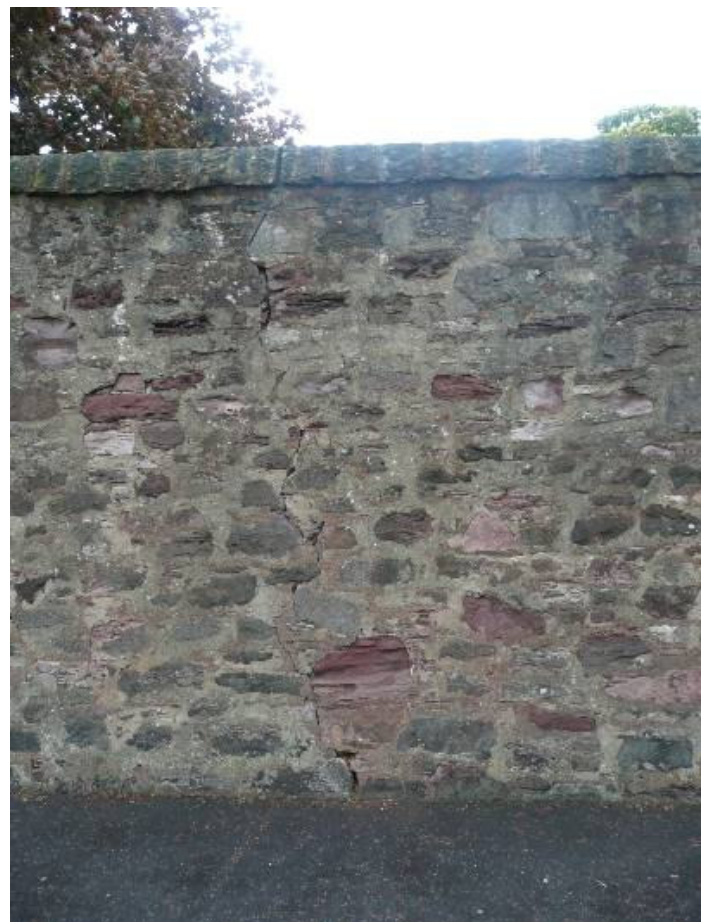
Cracks through wall

Moving round on the Warrender Park Road there is a large crack at the corner of the wall running down through the cope to about half way down the wall. This needs to be repaired to prevent any further deterioration of the wall in this location. It does not appear to penetrate the full width of the wall, as it is not visible on the school side. There is another plaque on this boundary wall, again only visible from the school side.

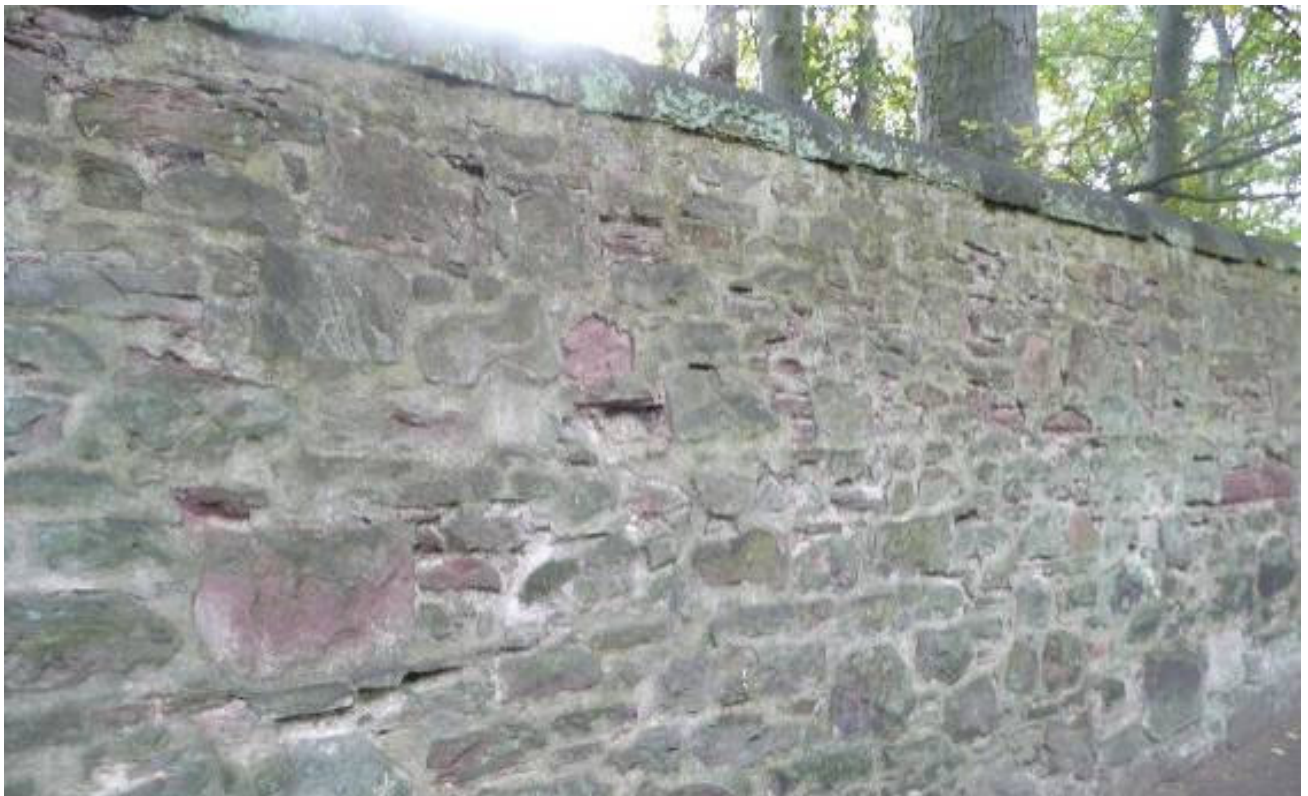
As this wall moves east there is evidence that it has been extensively repointed with a cement based mortar that has caused a disparity in weathering between it and the stonework. This is most evident in the upper areas that are predominately red sandstone. The mortar should be replaced with a lime based mortar and stones that have deteriorated need to be replaced or new cut in. There is an area of graffiti about halfway along its length that should be removed. There is also evidence that the mature Sycamore in this location has caused some movement in the wall. This should be monitored but at this stage there is no indication that it is of a level that would require the tree to be removed. The coping stones at this point have lost some of their mortar and would benefit from repointing.

Damage to stonework and copes on north boundary wall

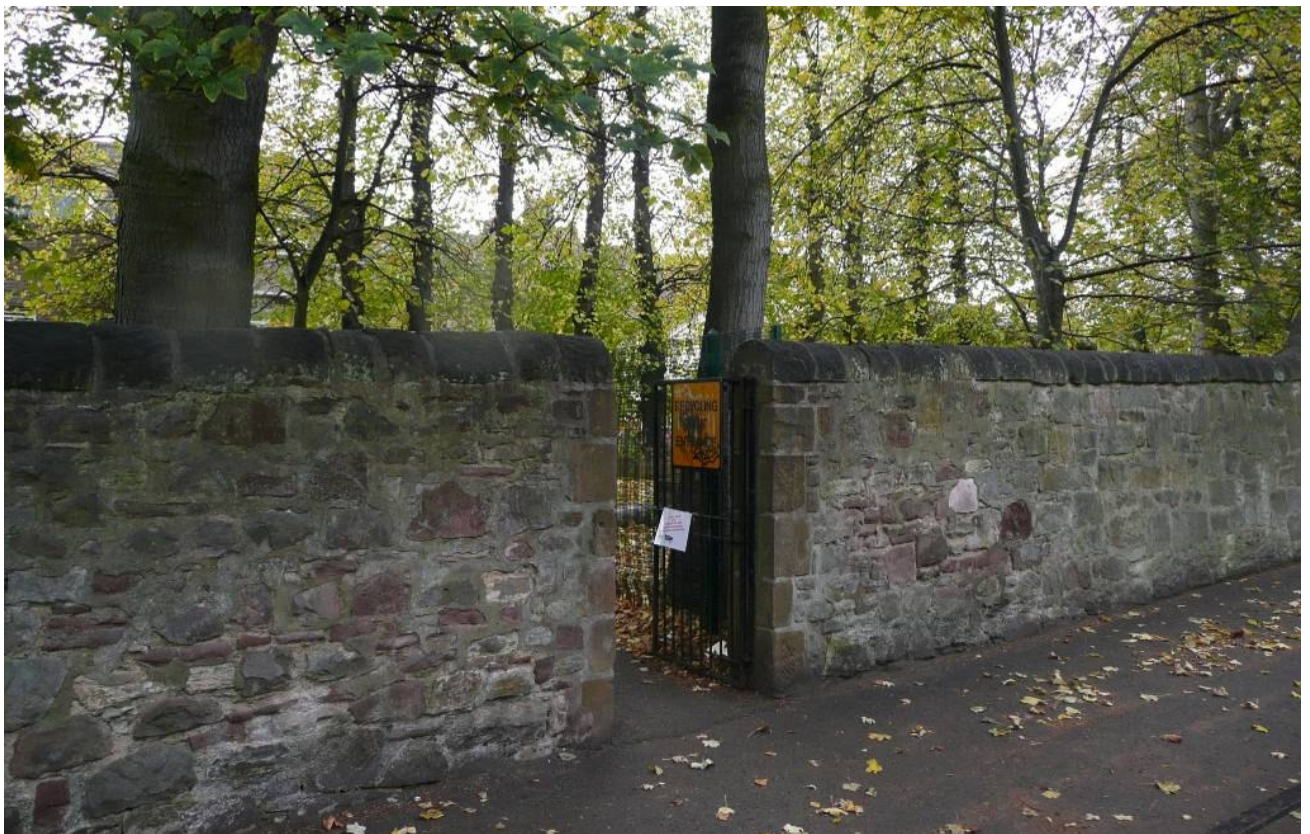
Damage to stonework and copes on north boundary wall

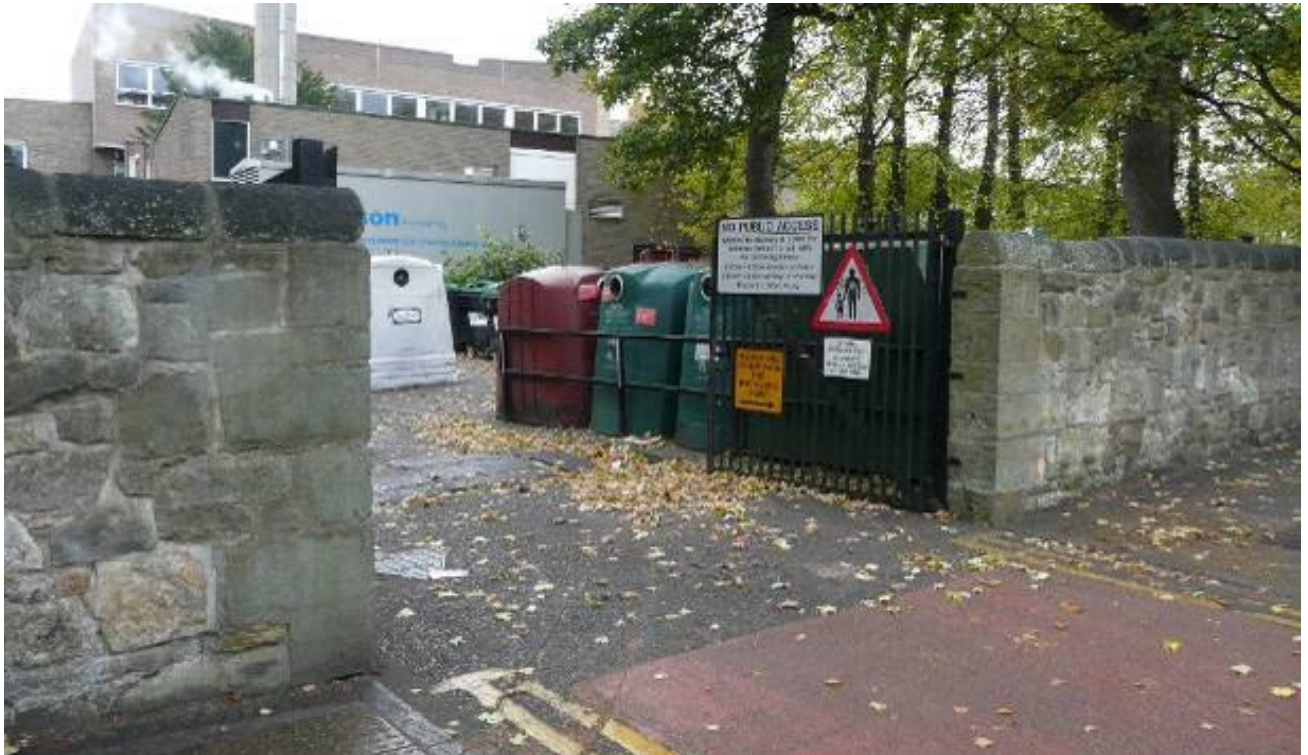
Directly opposite the junction with Marchmont Street there is newer vehicular access gateway to a recycling area. This has just been cut into the wall and no gatepier details have been introduced. The right hand side of the wall, when viewed from inside the site, has four large metal straps that have been installed to support the wall. The wall in this area needs to be made good. If this entrance is to remain as any form of main entry into the site then it should have ashlar gatepiers with pyramidal caps.

Vehicular entrance to north boundary wall

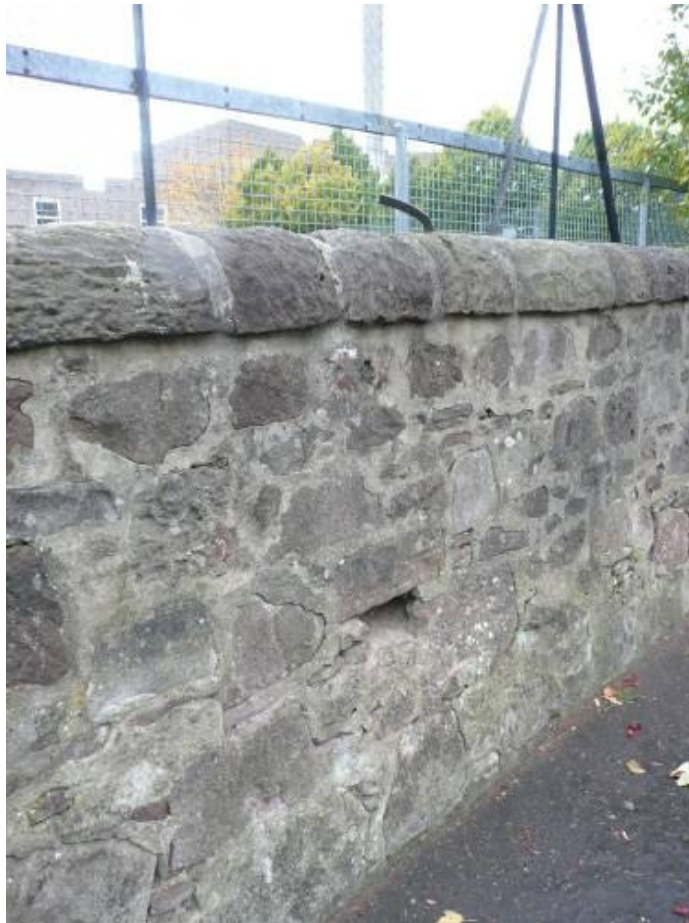
Towards the east end of this wall, at the Lauderdale Street end, there are some areas of dislodged and missing stonework. These need to be replaced. The wall is at its lowest at this point, having sloped down a couple of courses at the start of the outdoor pitch.

Dislodged and missing stones

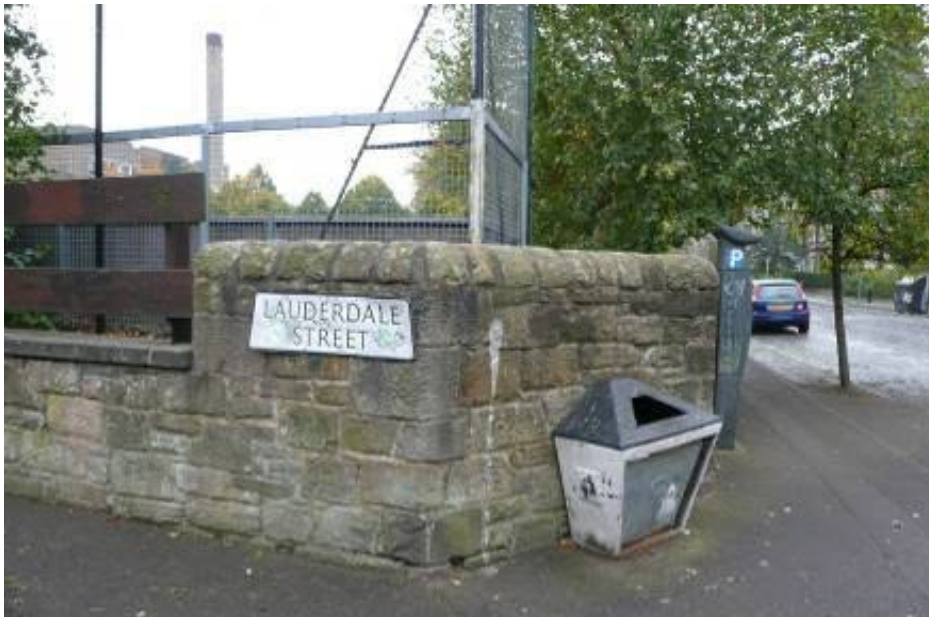
Once on Lauderdale Street the wall drops its height again to about 1m along its length, and it has wide horizontal timber fencing above. In general this later section of wall is in good condition although the concrete copes have not worn well. There should be stone copes to the wall to maintain its integrity with the rest of the boundary. As these would be an obvious later addition they do not have to be half barrelled. Between the wall and the outdoor pitch there are a number of Birch trees that have been planted between the fence and the wall. It is likely that as they mature they will affect the wall, although there is no evidence of this at present.

Drop in height at north end of Lauderdale Street

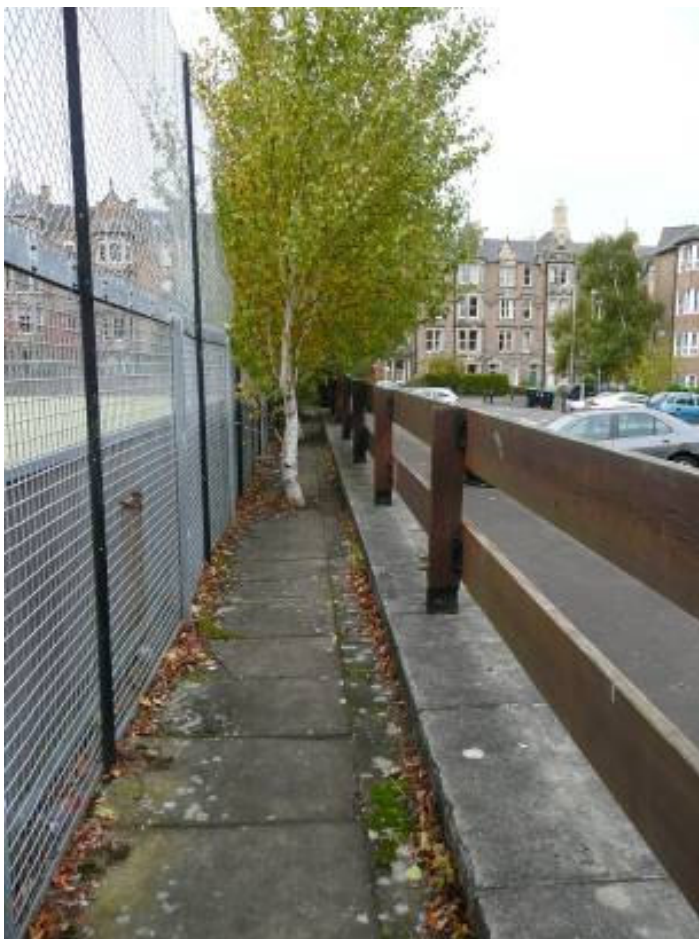
Birch trees between fence and boundary wall.

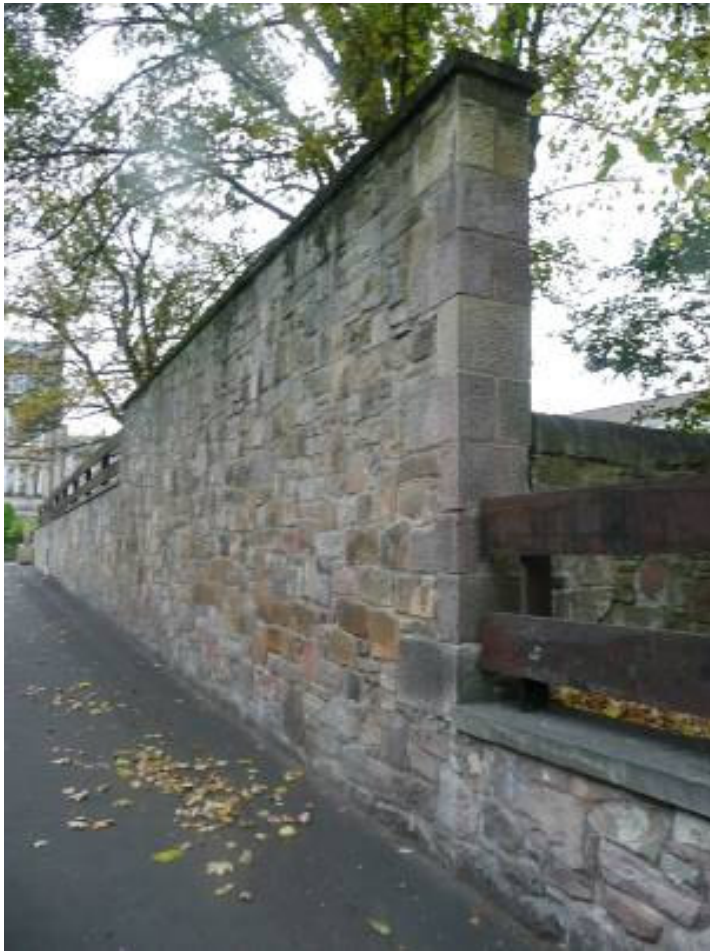
The south end of this wall is considerably higher and constructed from stone that has evidently been previously installed in another structure such as a small building. Some of the stones have evidence of metalwork and also they are dressed. This wall and its construction should be retained.

Higher boundary wall to south of Lauderdale Street

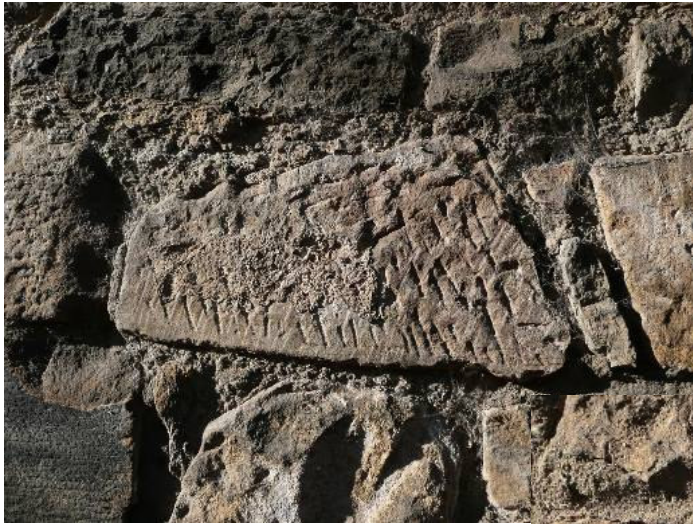
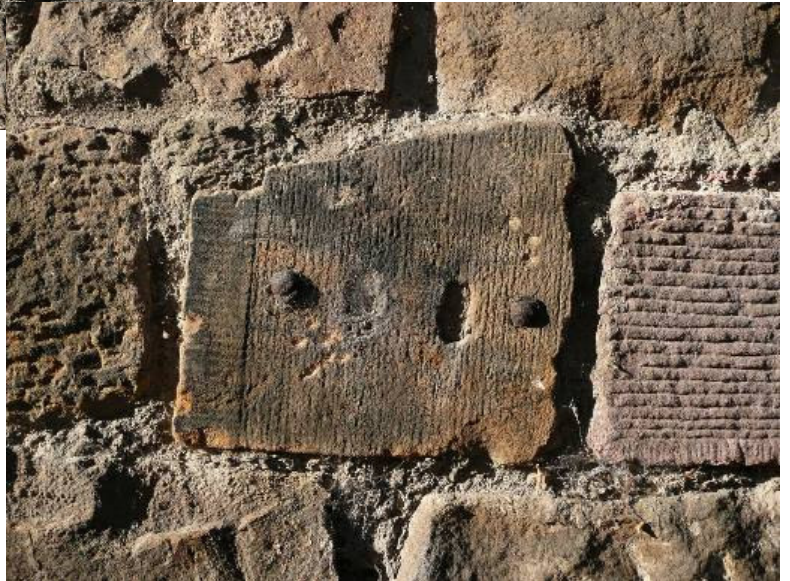
Dressed stones and evidence of metalwork

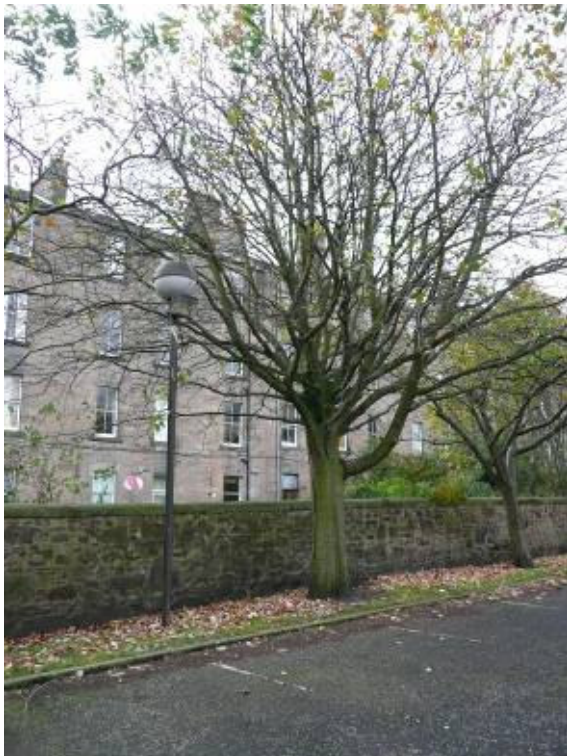
The boundary with the tenements to the south should be retained as is. The condition of this random rubble wall currently shows no signs for concern.

Boundary Walls to tenement gardens

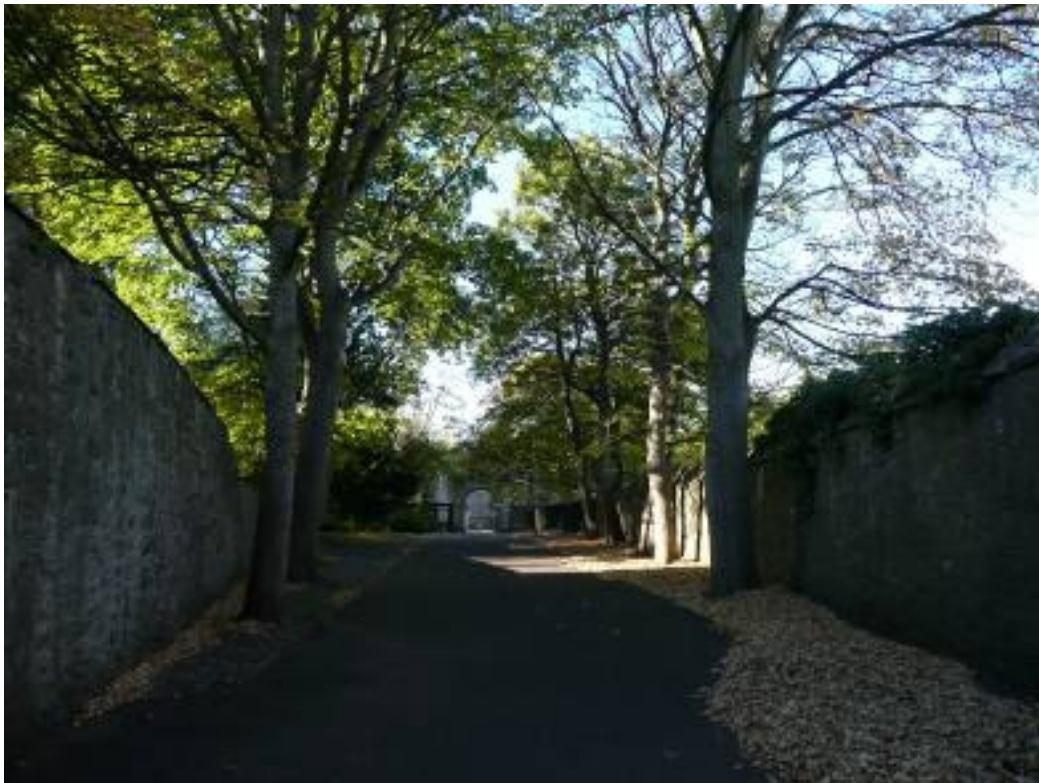
The wall that bounds the driveway to the school from Whitehouse Loan is a high coped rubble wall. They have an interesting pyramidal mortar cope detail. In areas this is deteriorating badly due to plant growth. The roots of nearby trees undermining it have also affected the wall. There are areas where there are stones and sections of cope missing. This needs to be repaired and new stones and lime mortar reinstated.

Boundary wall to driveway

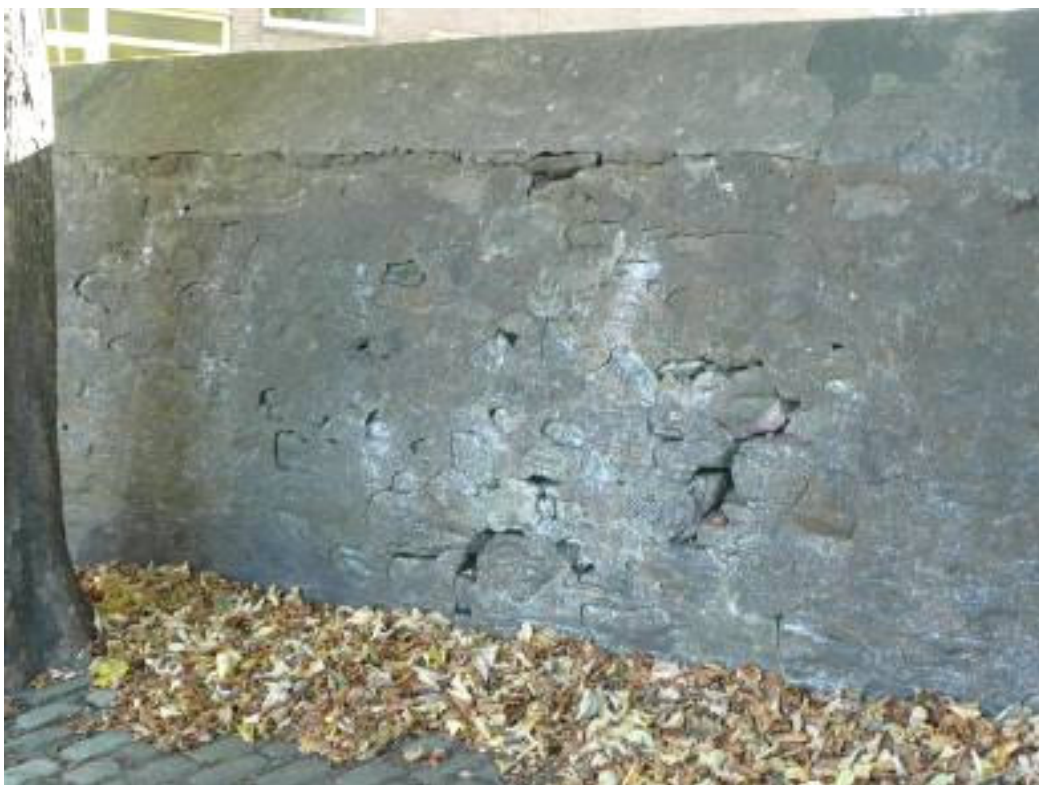
Area of stone affected by incorrect mortar

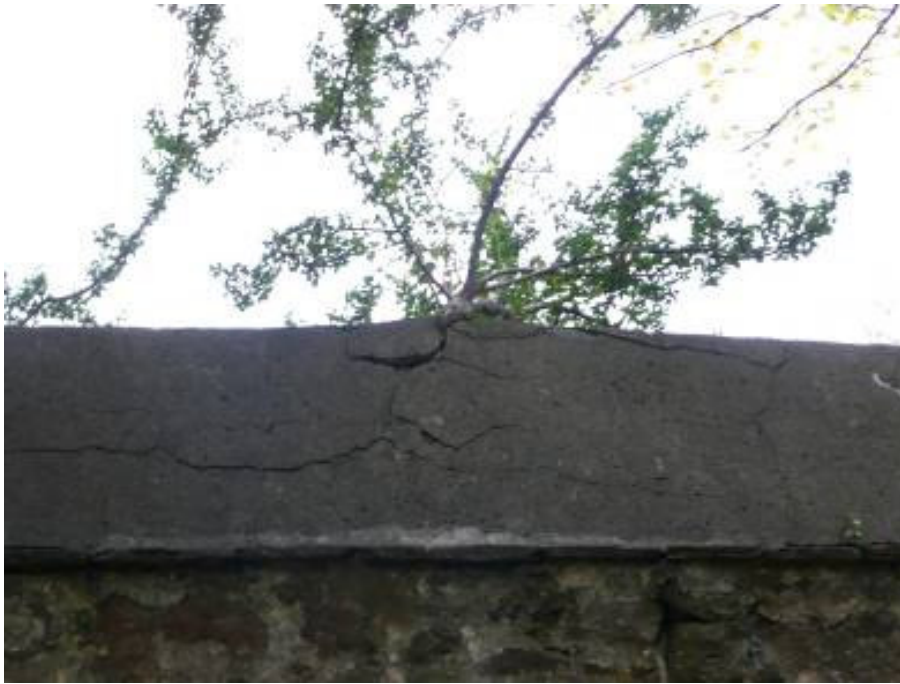
Plant growth affecting pyramidal mortar cope

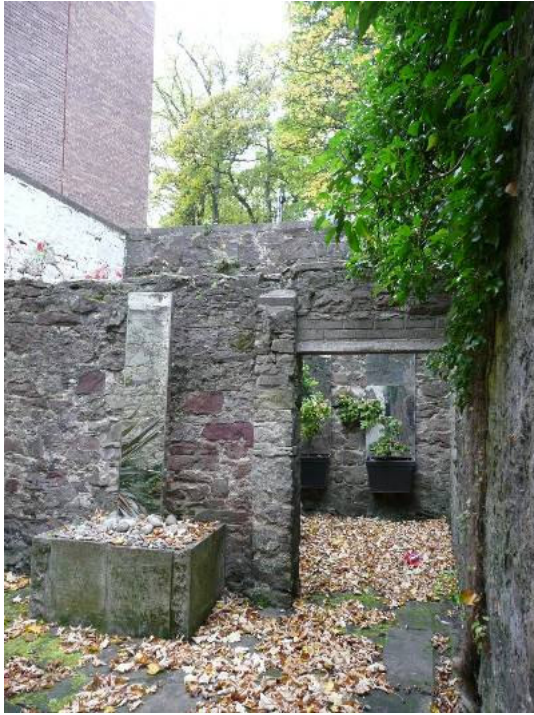
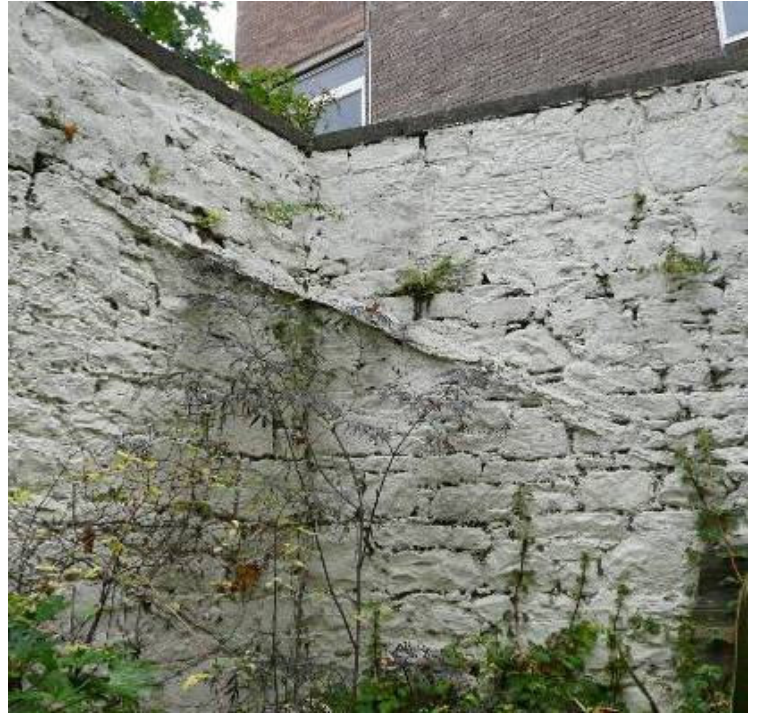
To the right of the arch to the school there is a small walled garden. It appears to have been formed from the walls of a small ruined building. The wall here has undergone some works in the past, most noticeably the introduction of a concrete lintol with brick infill to the entrance. This area is interesting within the landscape of the site and the wall should be repointed and the entranceway made good in stone to match original. Items like the low level window opening also add interest and are part of the history of the site. The bars to it need repainting and repositioning, and the timber frame should be replaced and painted to protect it.

Walls to Alison Laidlaw Memorial garden

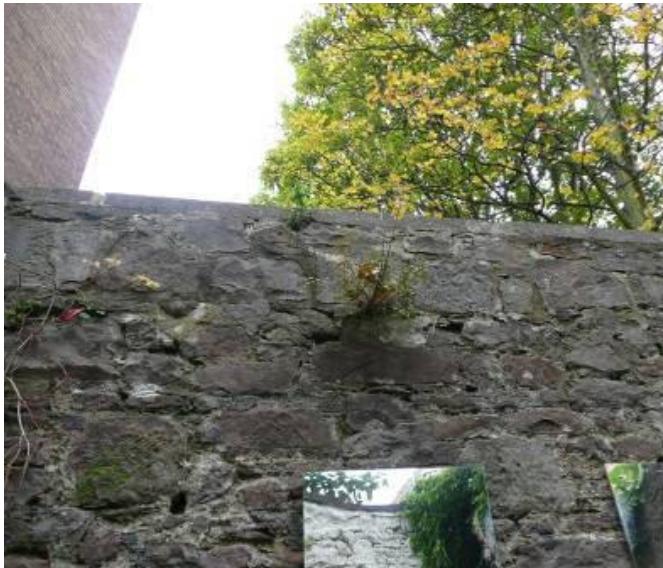
Plant growth in wall

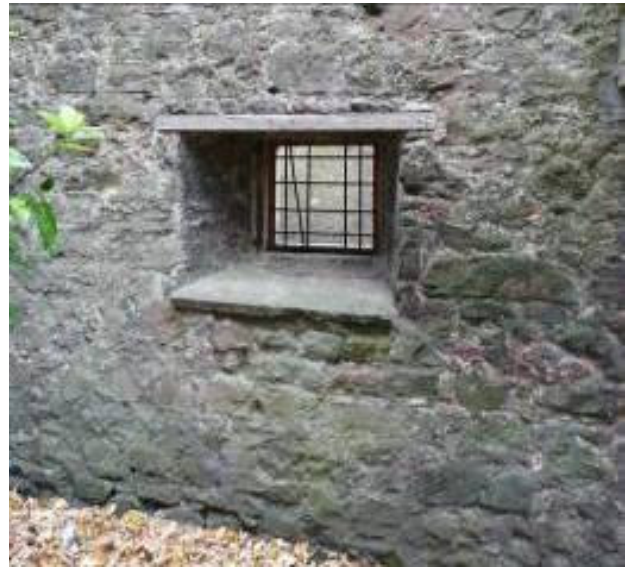
Bars to old window opening

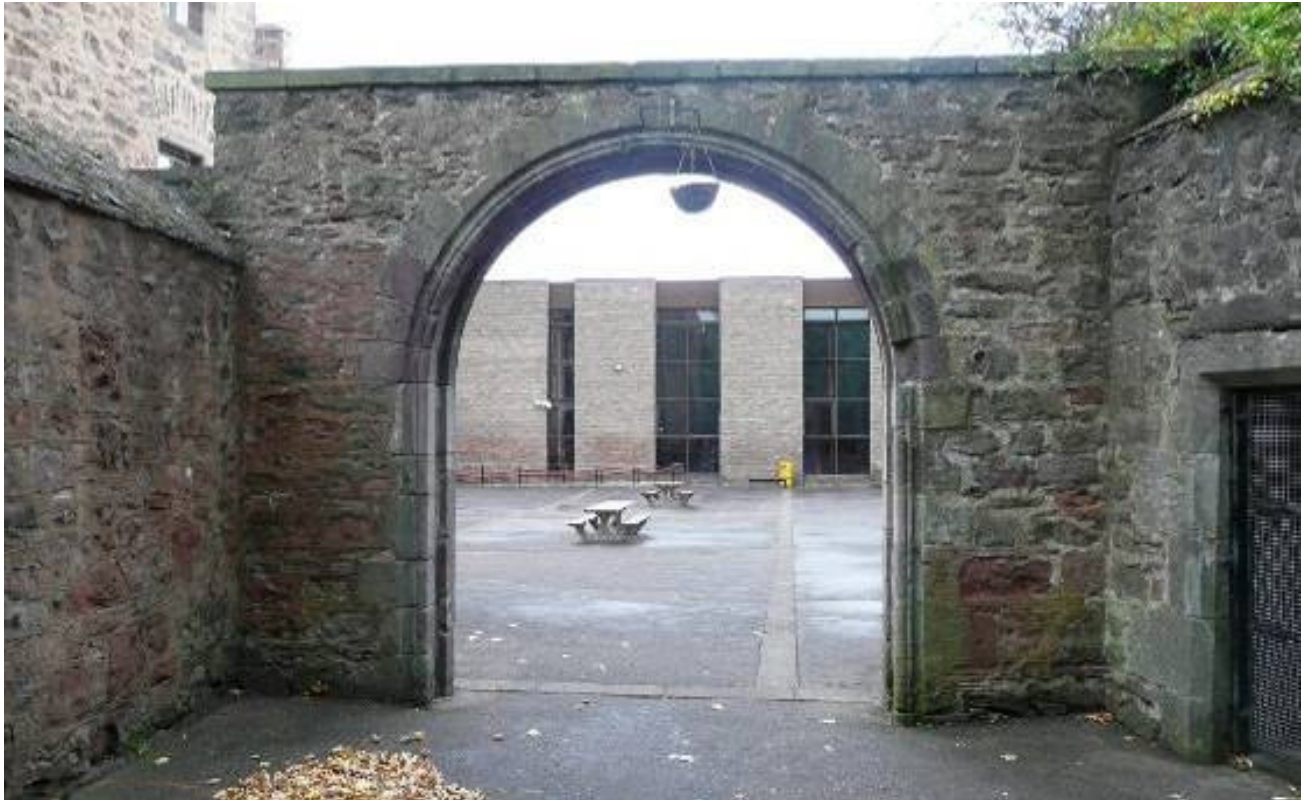
There is damage to some of the stones forming the archway at Bruntsfield House. These need to be repaired/ replaced and missing stone beneath the cope reinstated.

Archway leading to Bruntsfield House

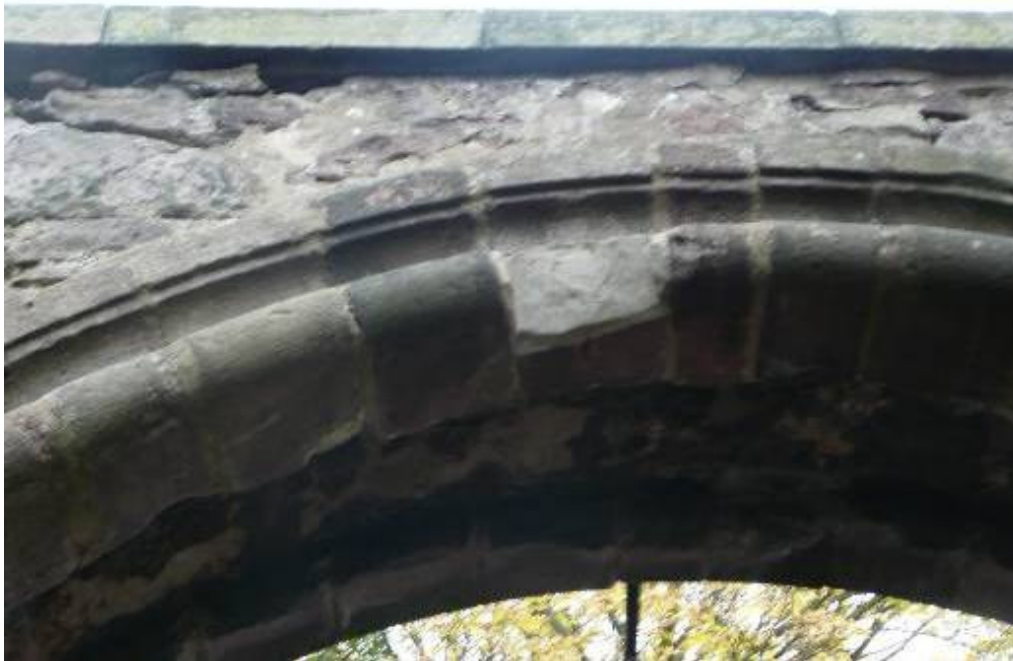
Damage to arch connecting to Bruntsfield House

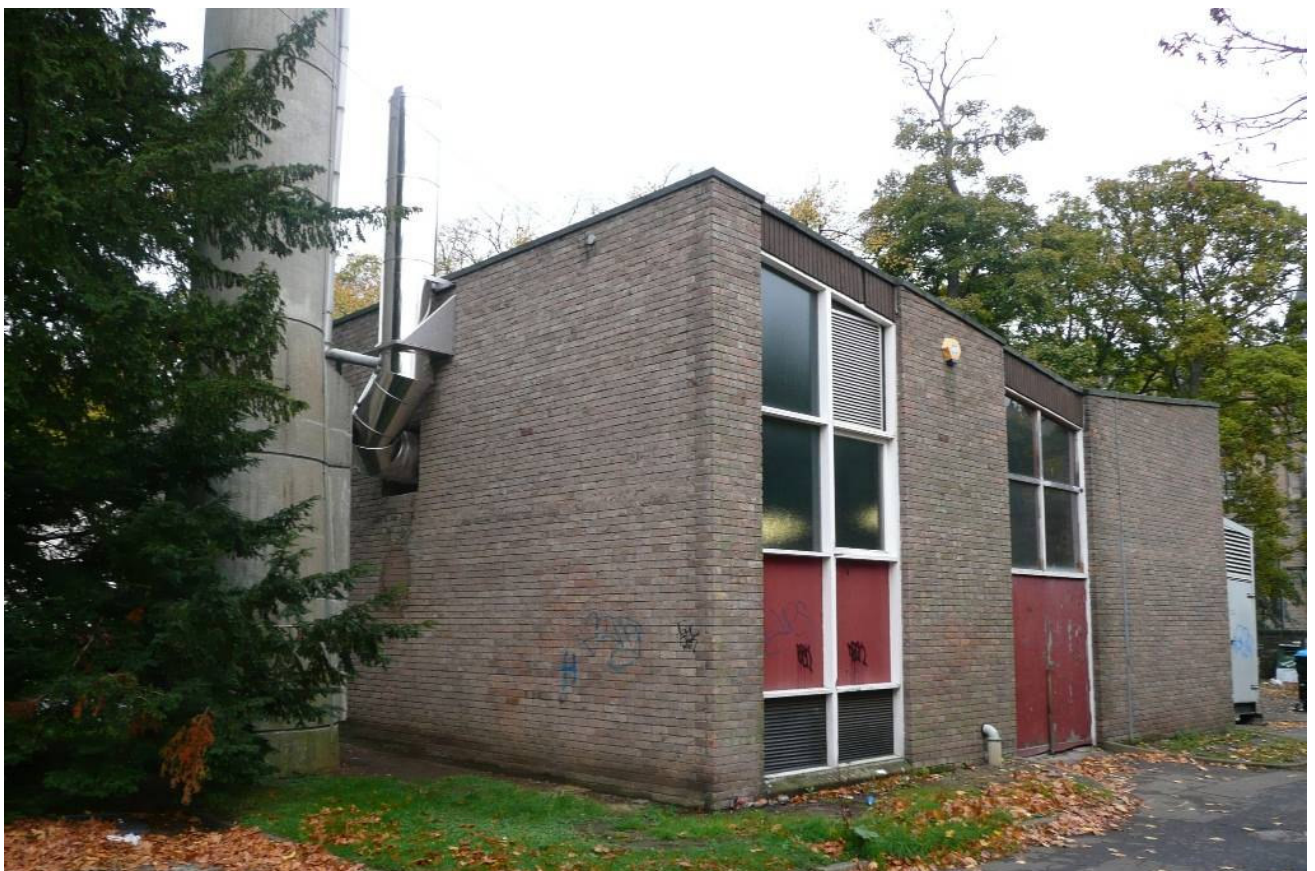
Buildings such as the boiler house and nursery are of no significance and can be removed. The primary school is of neutral architectural merit. Painting it a colour more in keeping with the historic structures on the site could soften the white render to its upper level. This would also minimise its impact when seen from outside the site in the wider Conservation Area.

Boiler house to the north of the site
